Table 3.2-1
SUMMARY PRESENTATION OF DAMAGED BUILDINGS AND INFRASTRUCTURE
FACILITIES IN DAGUPAN CITY, DUE TO LUZON EARTHQUAKE OF 16 JULY 1990
 (Source: Mayor Office of Dagupan City and AIJ, 1990)

3.3. Land Instabilities and Other Earthquake Effects

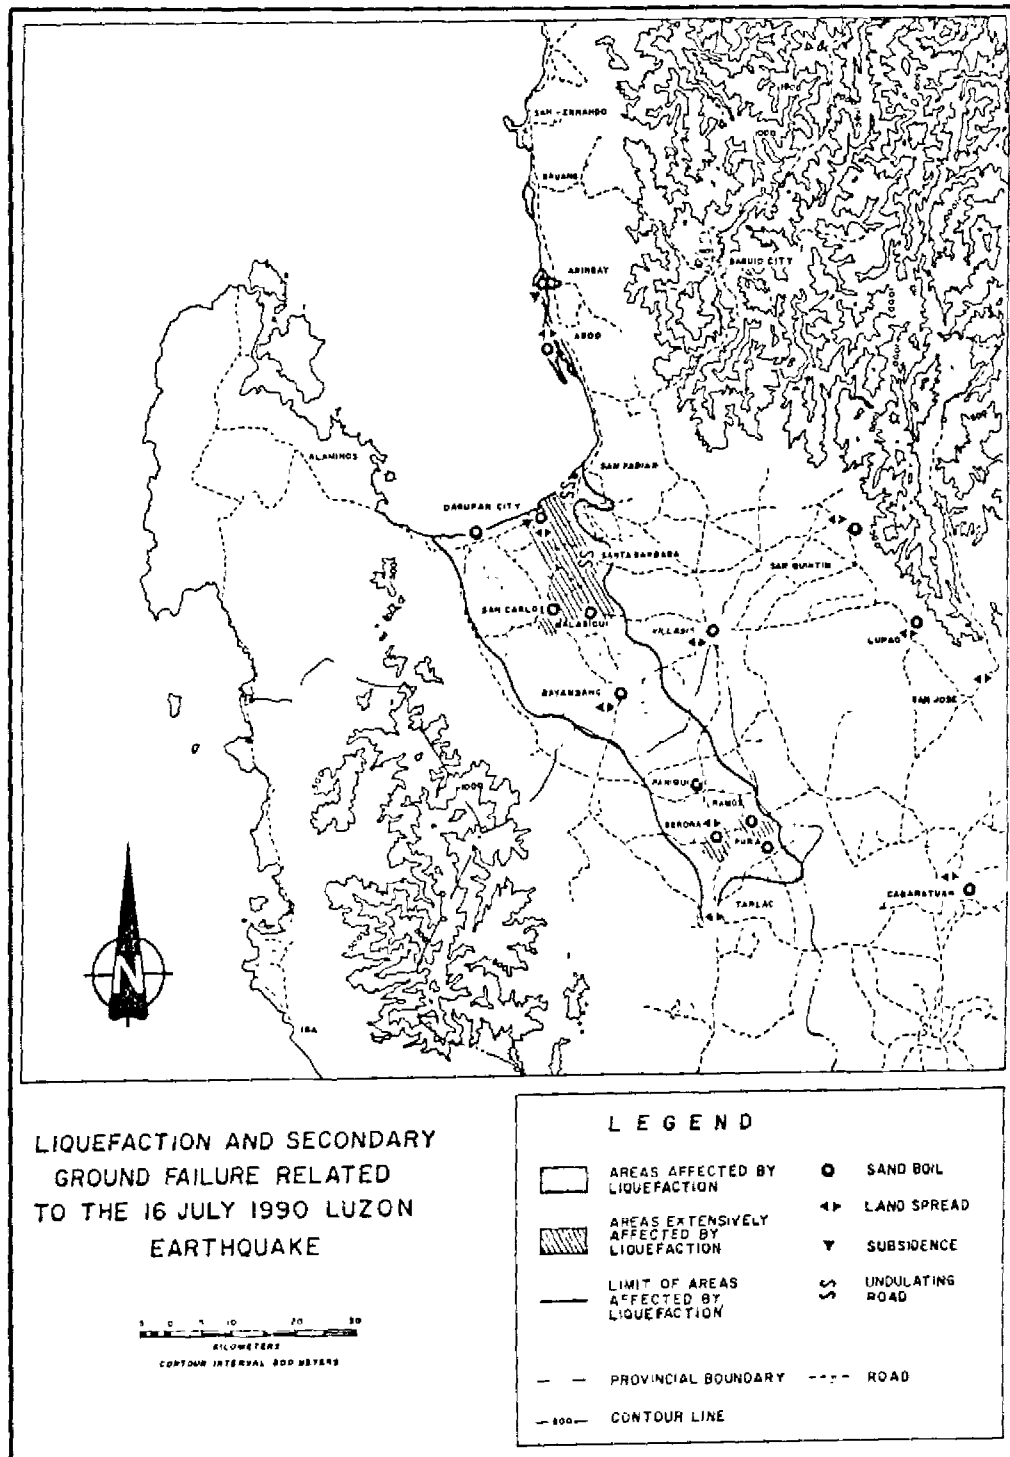
Fig. 3.6 Liquefaction and ground deformations related to the 16 July 1990 Luzon Earthquake in the wider area of Dagupan City (from PHIVOLCS, 1990).

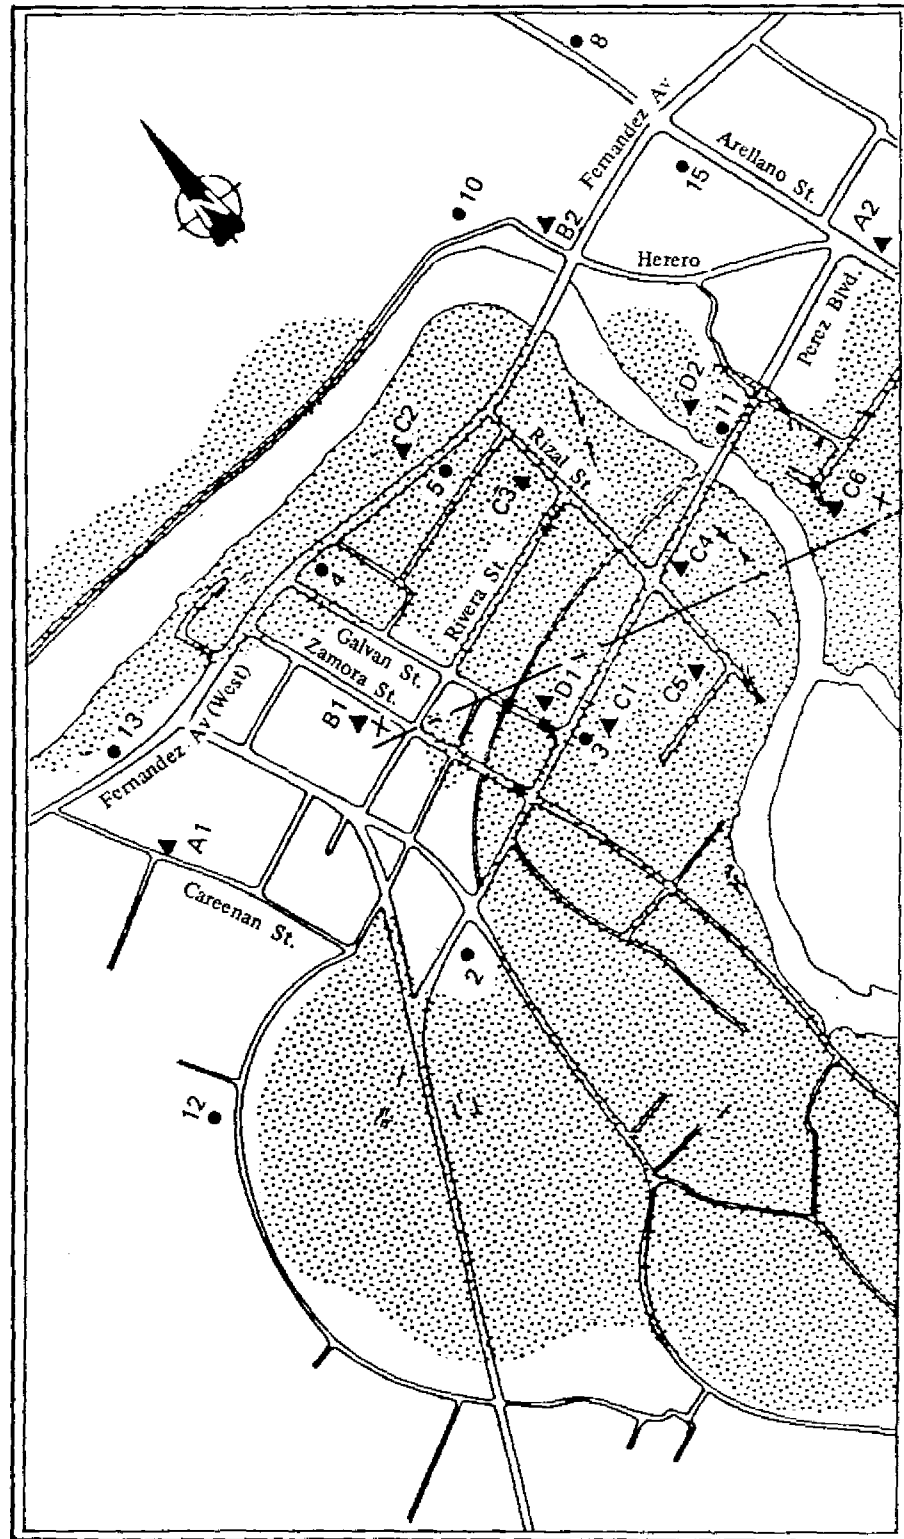
Fig. 3.7 Zones with observed intensive liquefaction and lateral spreading in the central commercial district of Dagupan City, with the locations of SPT test sites (2 - 16), microtremors (A,B,C), and Rayleigh wave field measurements (from PHIVOLCS, 1990, and Tokimatsu, K., 1990).

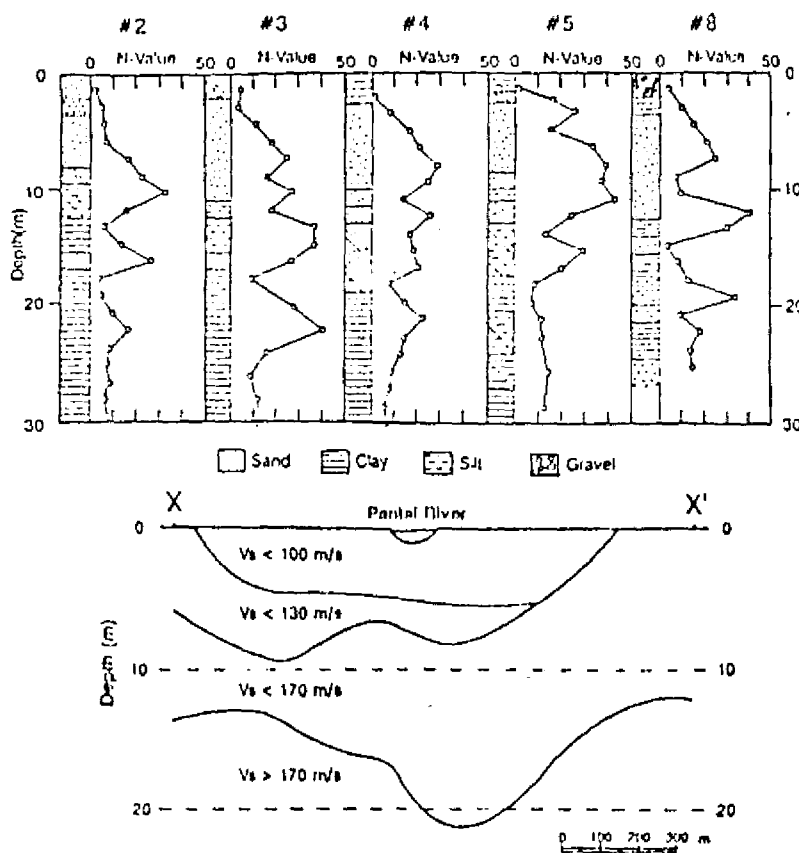
Fig. 3.8 Boring logs along Perez Blvd. (#2 and #3), Fernandez Avenue (#4 and #5) and at Arellano St. (#8), with cross-section of shear wave velocity profile along x-x line. (from Tokimatsu, K., 1990).

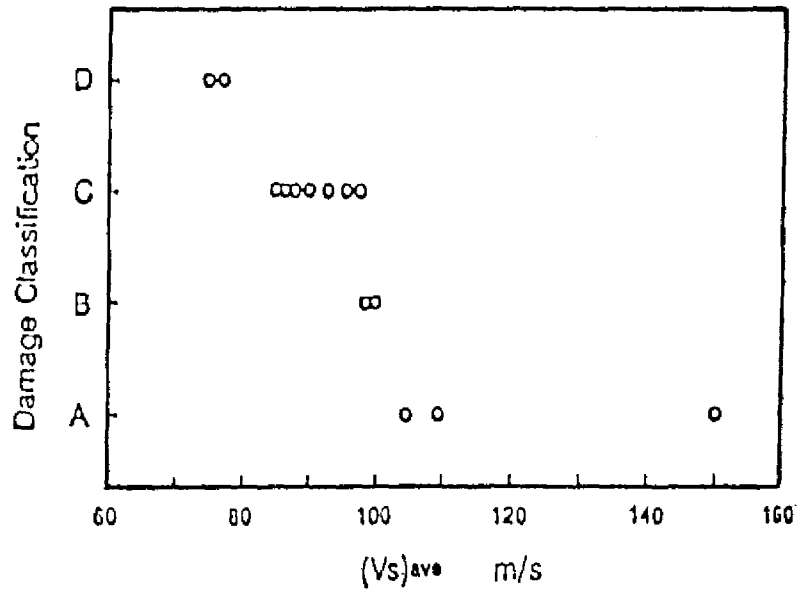
Fig. 3.9 Relation between average shear wave velocity and buildings earthquake damage category (A - no or slight damage, II - small, III - medium, IV - severe damage, V and VI - partial or complete collapse) as classified r.c. buildings, in Dagupan City central area (from Tokimatsu, K., 1990).

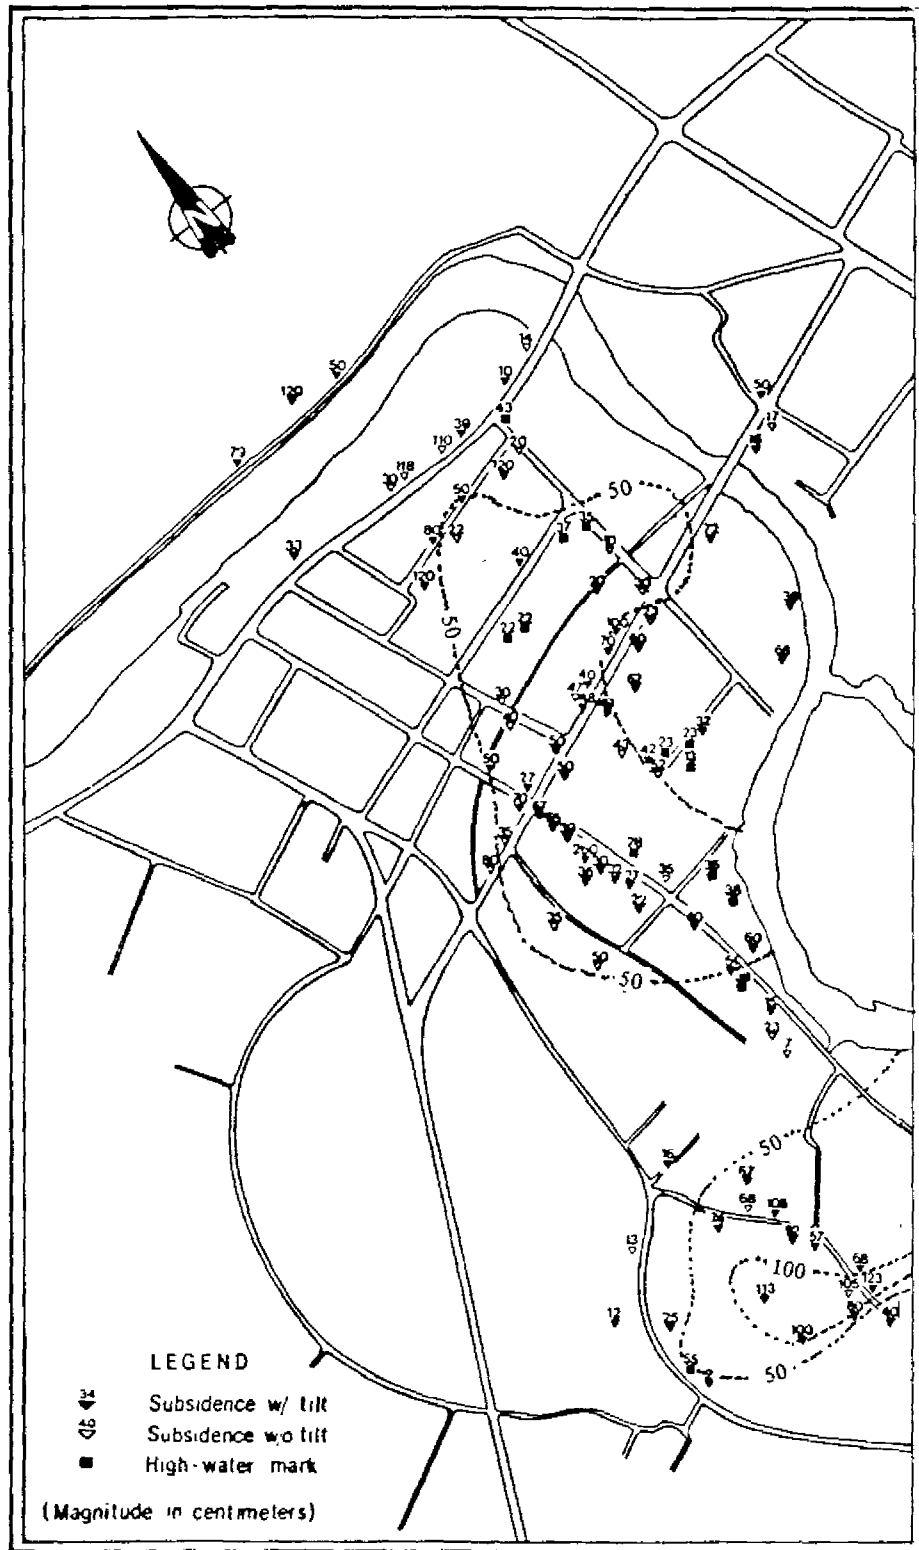
Fig. 3.10 Relative settlement of the buildings in the Commercial district of Dagupan City with probable contour lines of equal settlements (based on the data from PHIVOLCS, 1990).

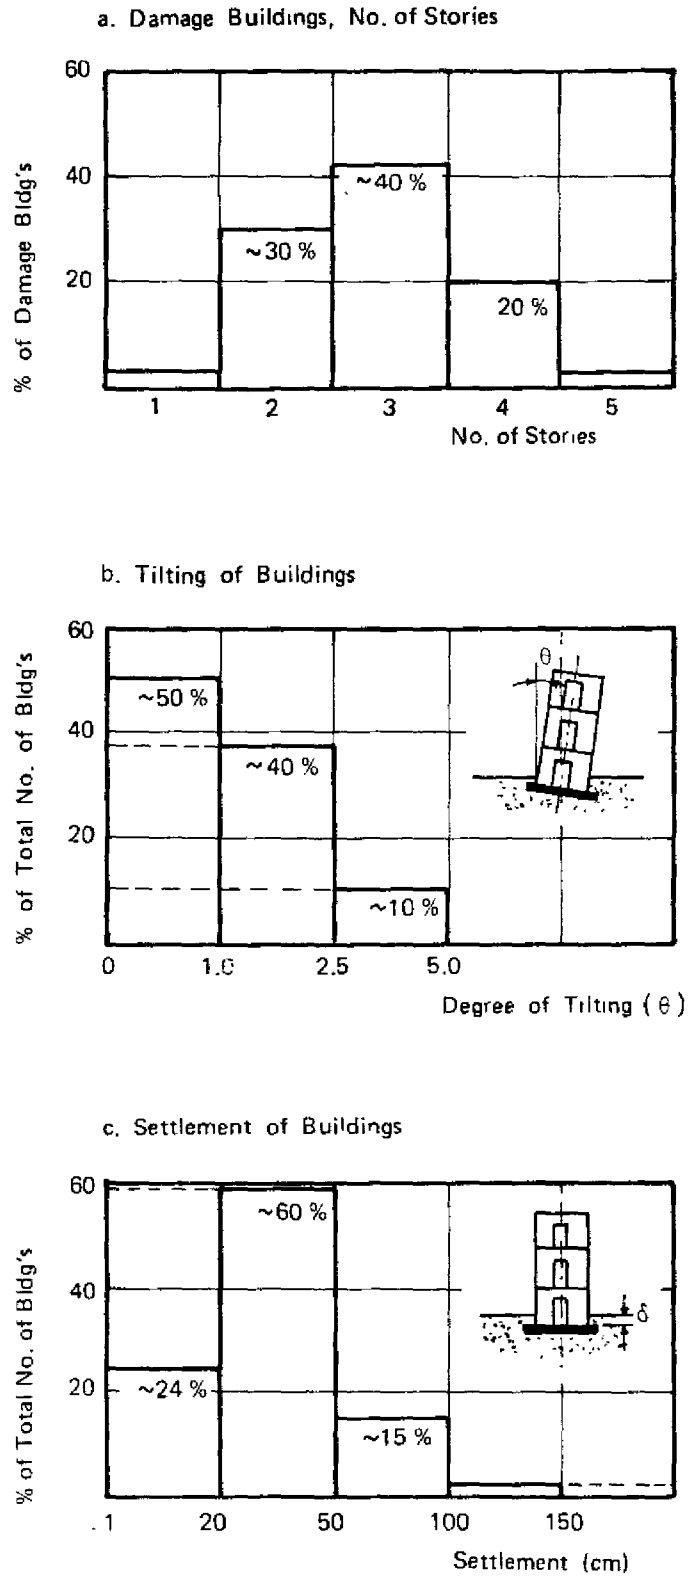
Fig. 3.11 Presentation of the dominant modes of earthquake - damage of r.c. 1 to 5-storey r.c. buildings in Dagupan City. a. number of storeys; b. intensity of tilting; c. intensity of settlement (based on the statistics presented in AIJ, 1990).

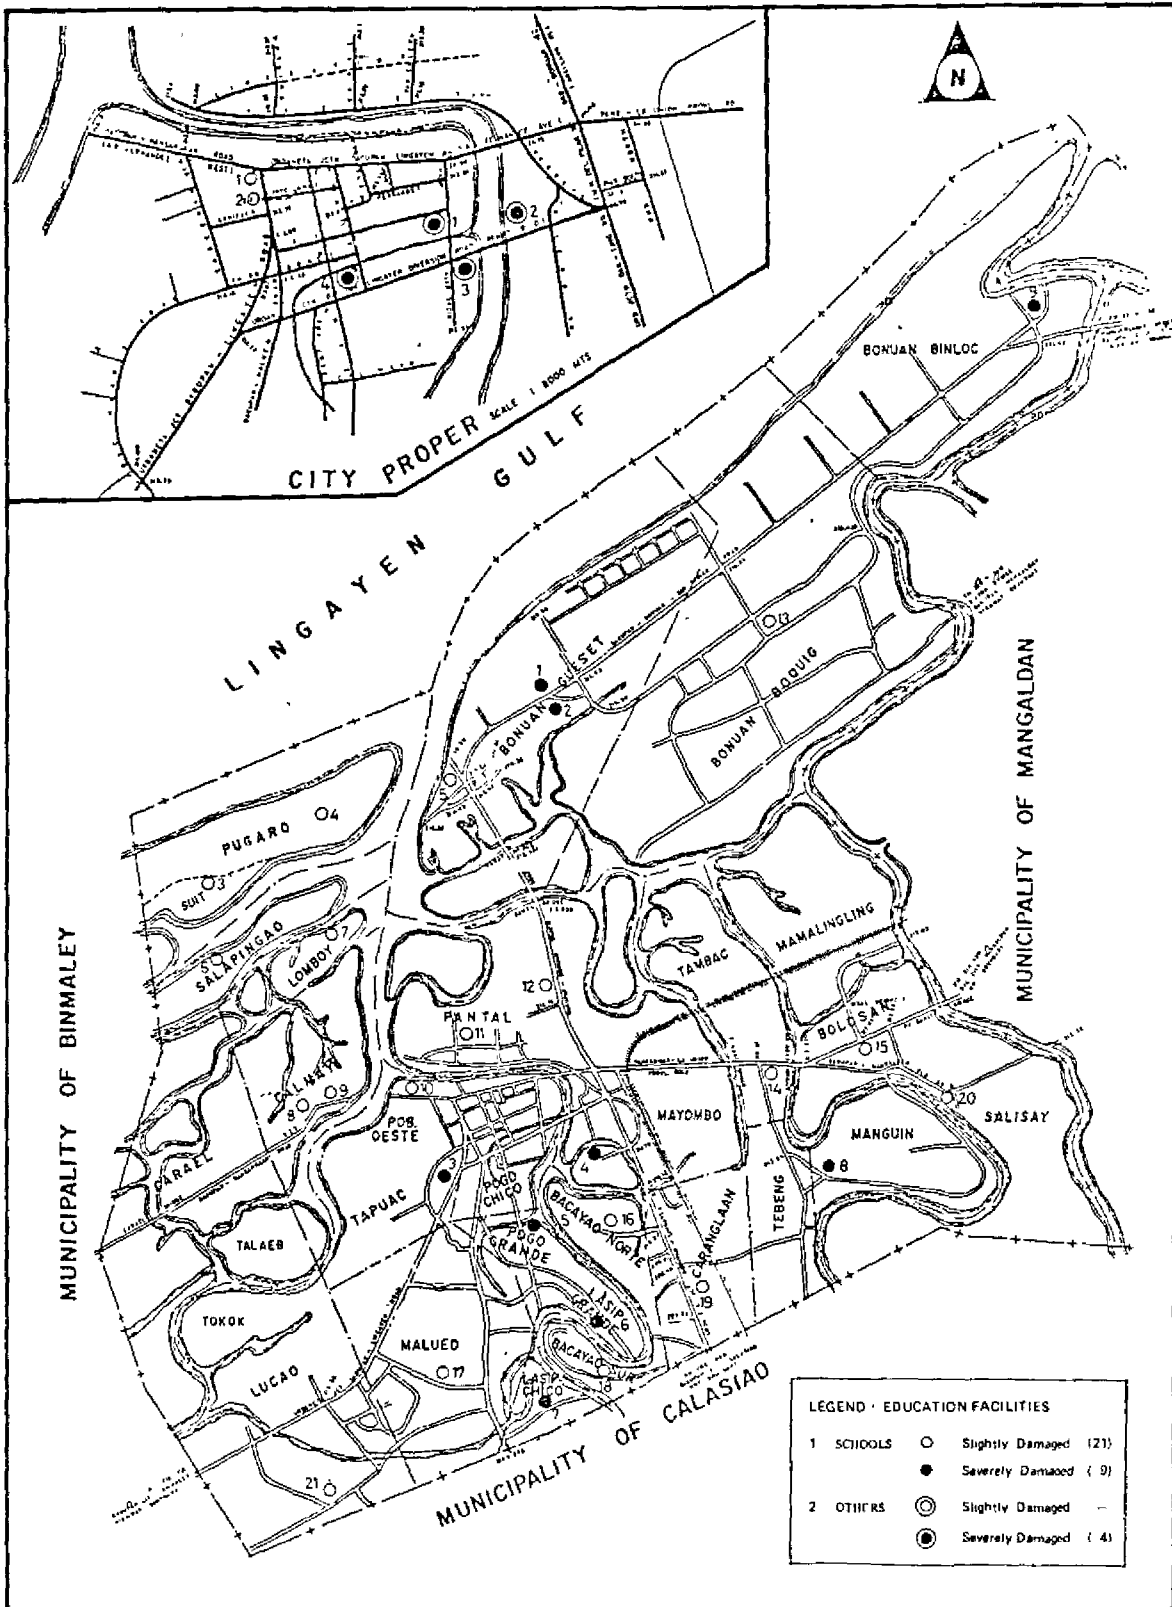
Fig. 3.12 Dagupan City. Distribution of damaged educational buildings due to the Luzon earthquake of 16 July 1990 (source: Mayor Office of Dagupan City)

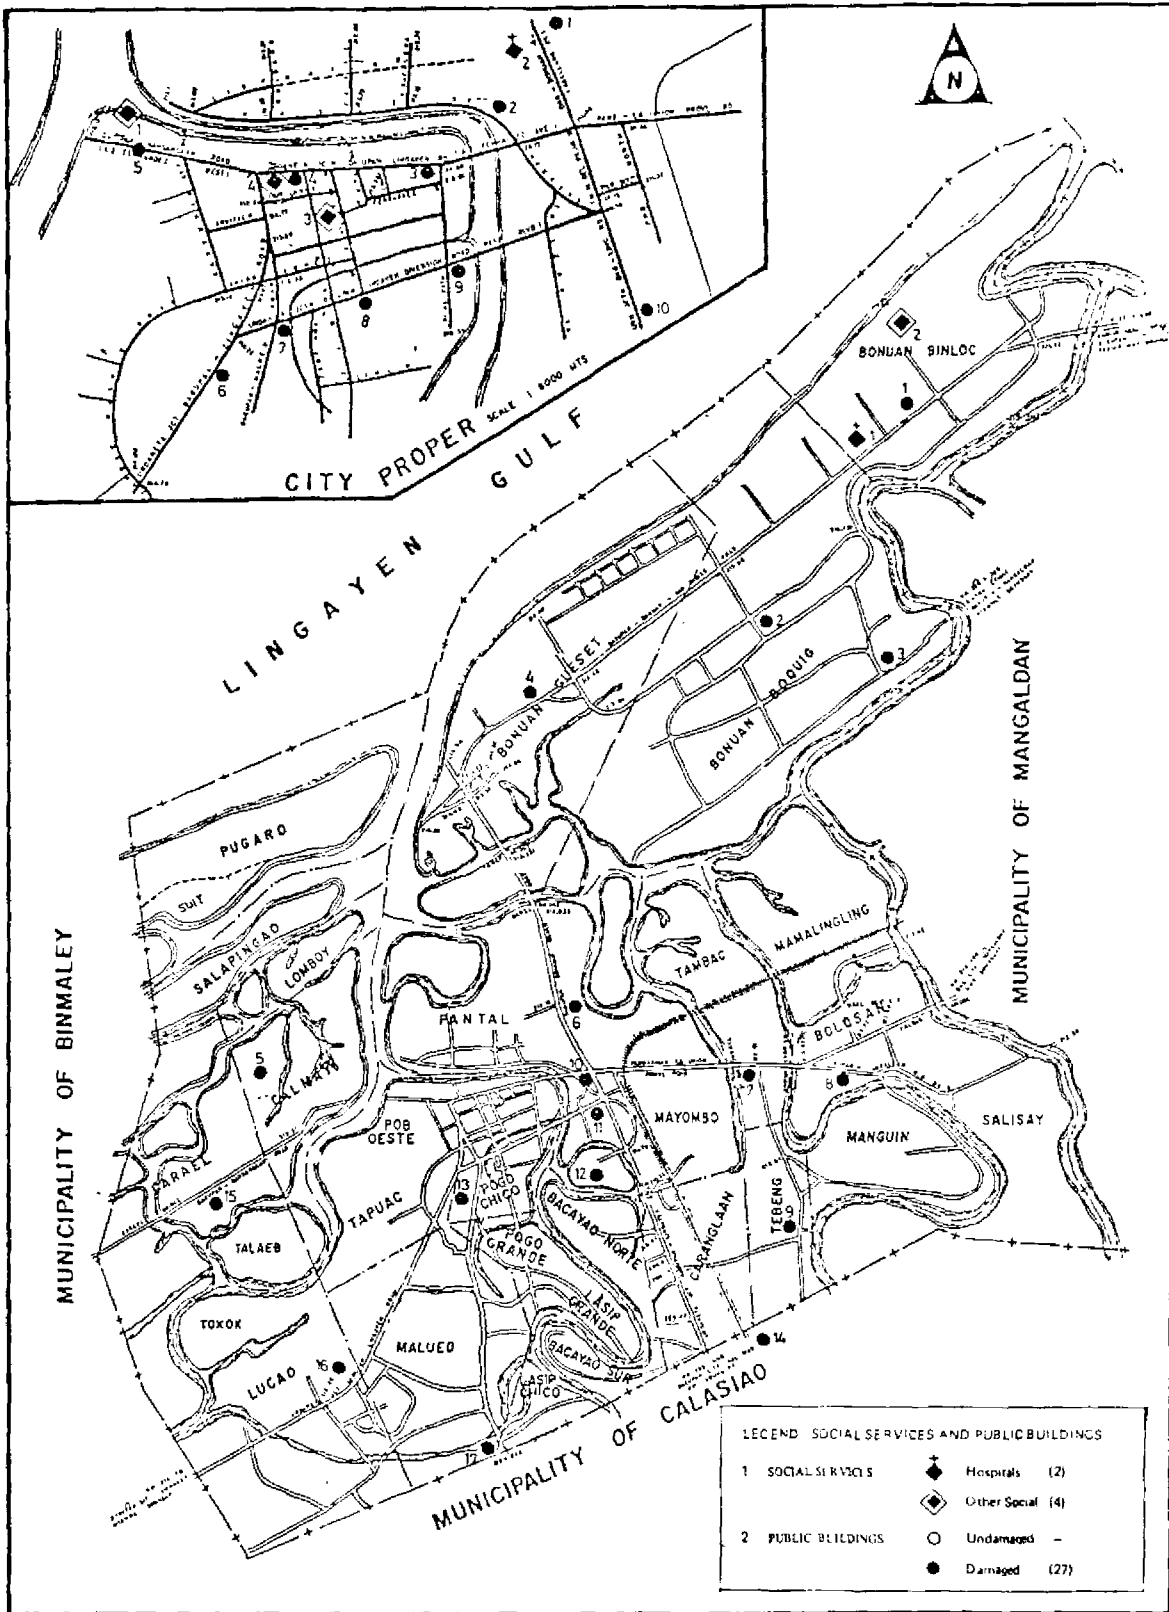
Fig. 3.13 Dagupan City. Distribution of damaged social services and public buildings due to the Luzon earthquake of 16 July 1990 (source: Mayor Office of Dagupan City)

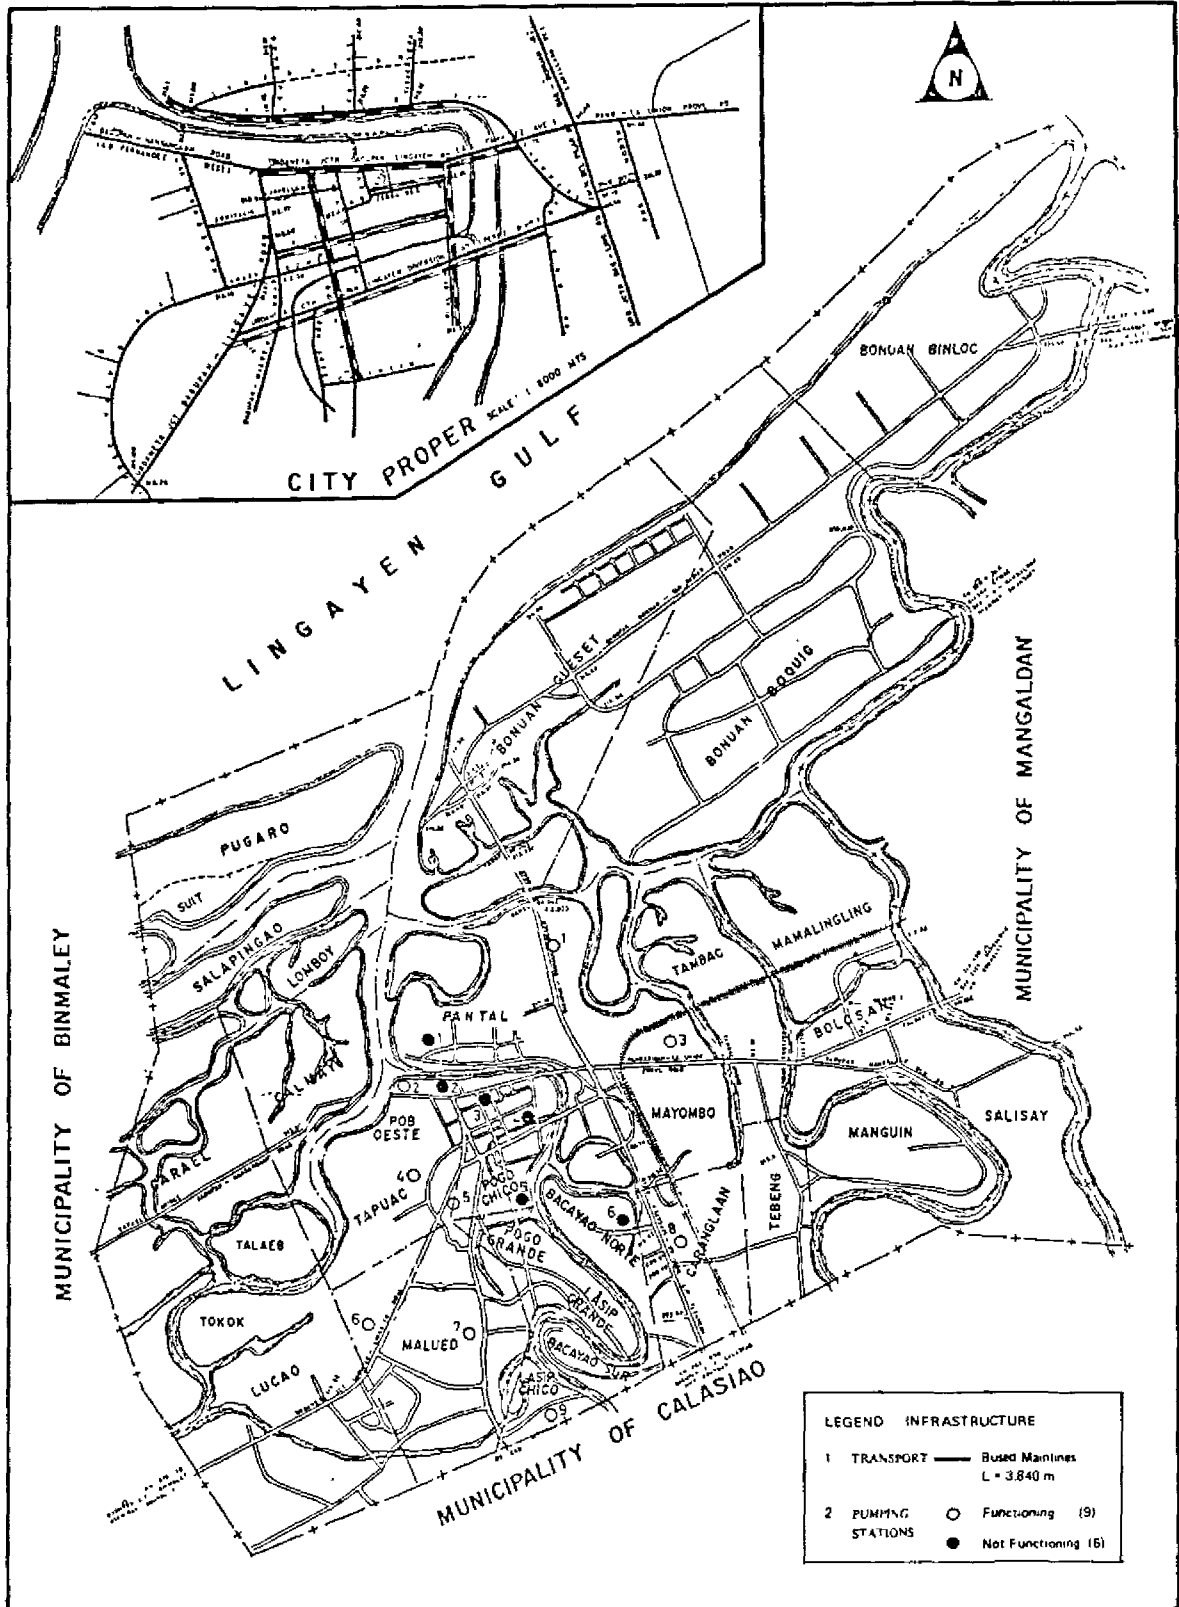
Major streets in the Commercial District as bused mainlines were heavily damaged in the length of 3.84 km. as shown in Fig. 3.14, mainly due to liquefaction and lateral spreading of surface soil layers

Fig. 3.14 Dagupan City. Distribution of damaged city center bused main lines (transportation system) and water-pumping stations due to the Luzon earthquake of 16 July 1990 (source: Mayor Office of Dagupan City)
