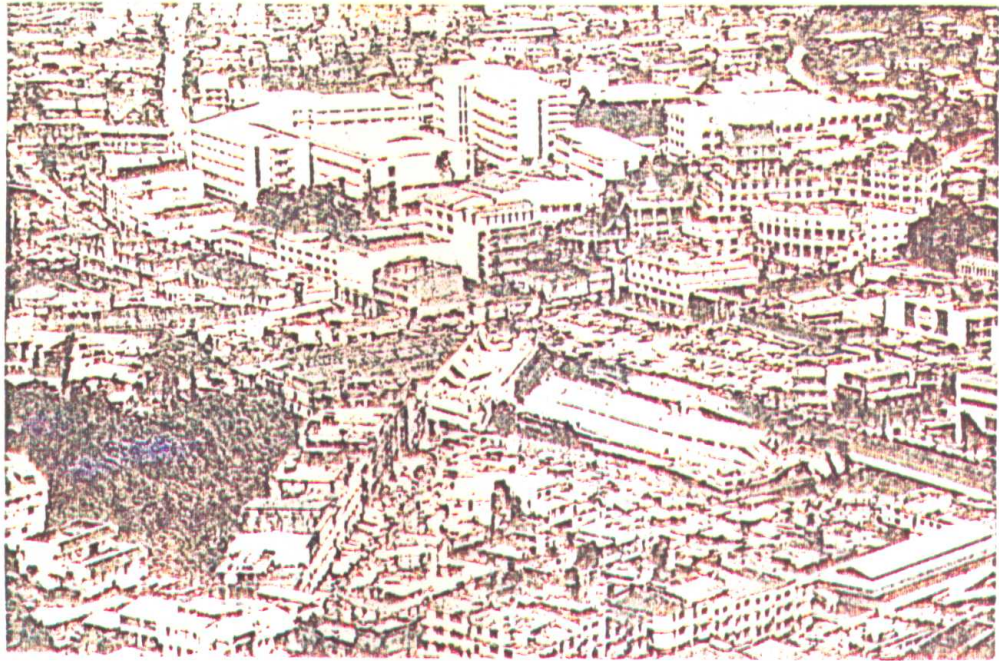
Photo 3.1 Aerial view of the central part of Baguio City with heavily damaged buildings and collapsed nine-storey hotel.

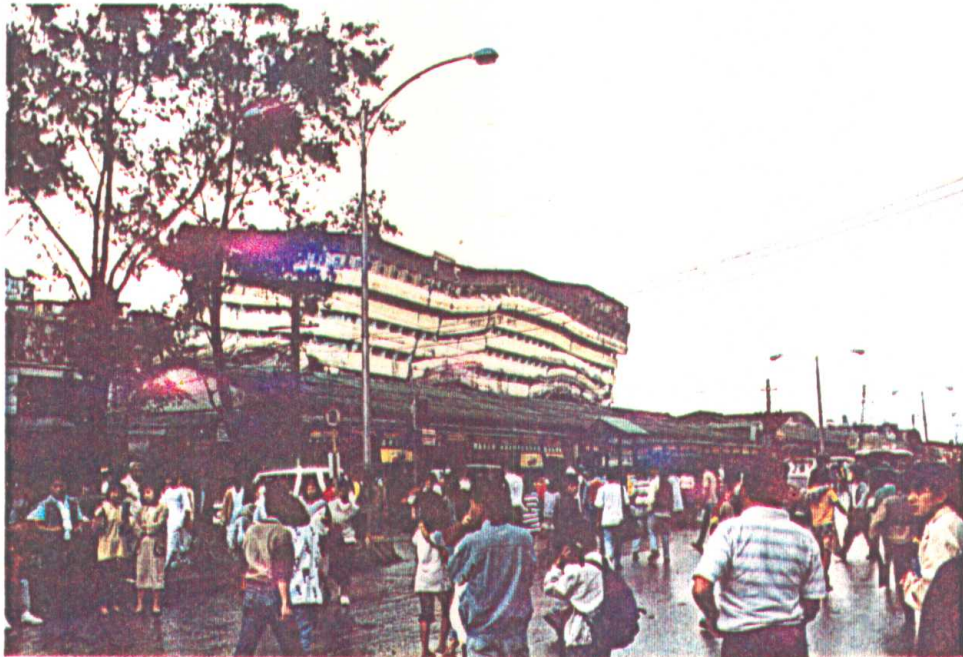
Photo 3.2 Collapsed Hilltop hotel, 7-storey r.c. building, in pancake mode of failure due to nonductile r.c. frame structure, heavy floor structures and deep facade (lintle) beams.

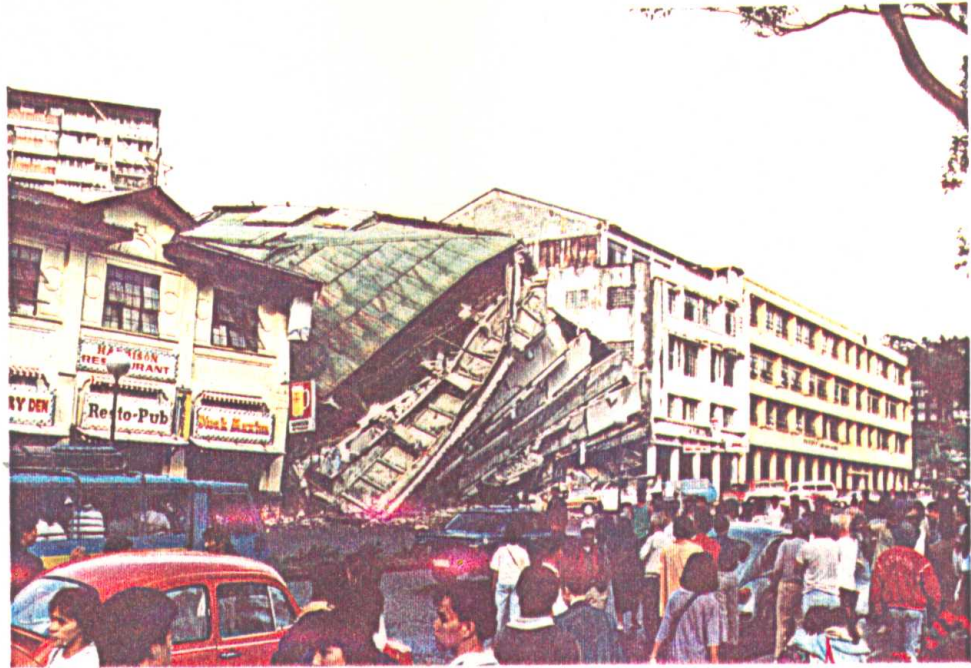
Photo 3.3 Collapsed Park hotel, 7-storey r.c. building, between effectively undamaged buildings on the same street. Typical brittle failure of load carrying structural system and heavy floor structure.

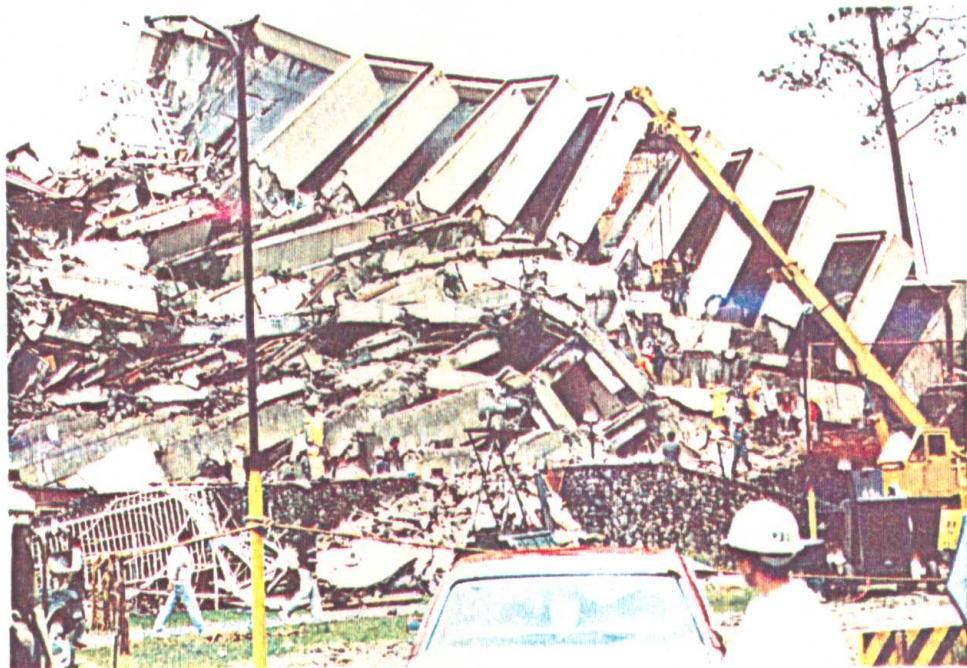
Photo 3.4 Brittle failure of the Hyatt Terraces hotel, 11-storey towers, typical misconceptual earthquake resistant design including other buildings in this hotel complex.
