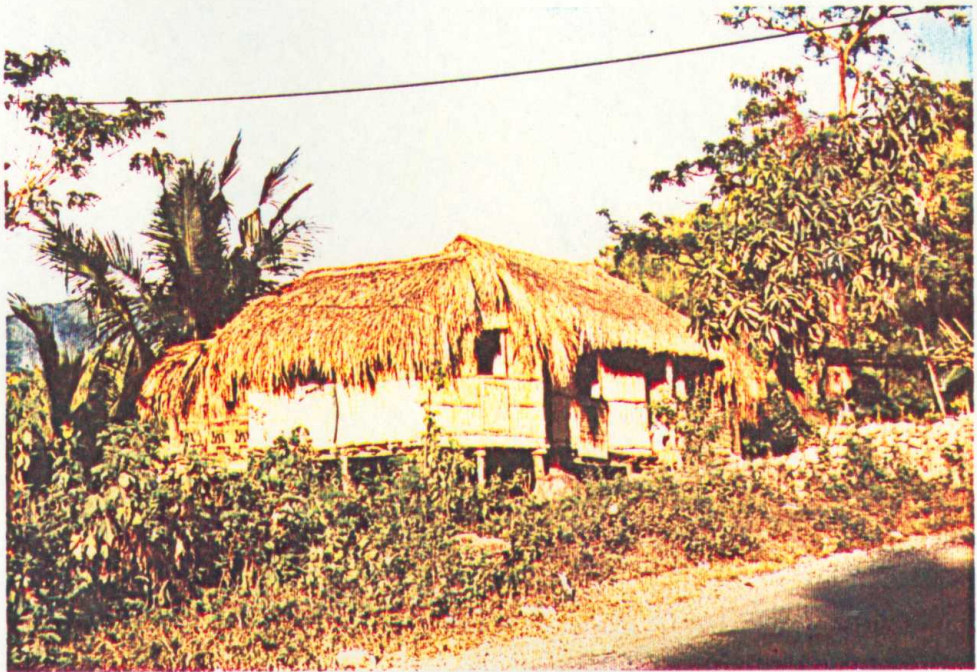
Photo 4.1 Traditional housing form in rural areas built from unshaped timbers, woven bamboo and palm thatch gathered locally. Such houses are light and resilient.

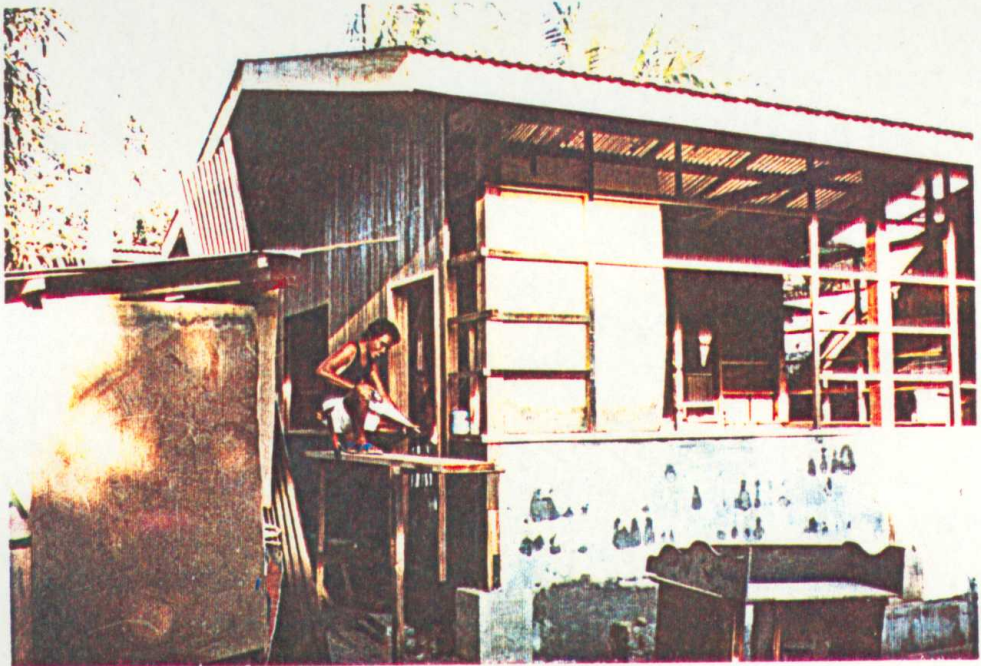
Photo 4.2 Cash-economy equivalent that comprises most of the residential building stock in urban areas and larger villages. Houses are built by professional carpenters with timber frames of processed timber, ground floor of masonry (concrete blocks) and light roof cover sheets.

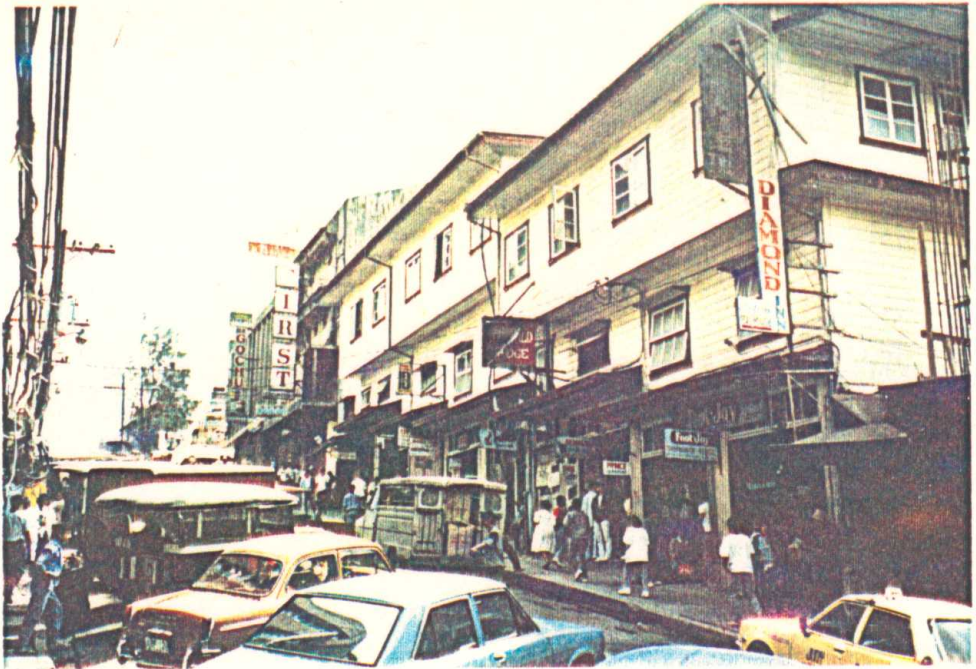
Photo 4.3 Small businesses in Baguio have been severely affected by loss of trade, although their buildings and premises are themselves undamaged.

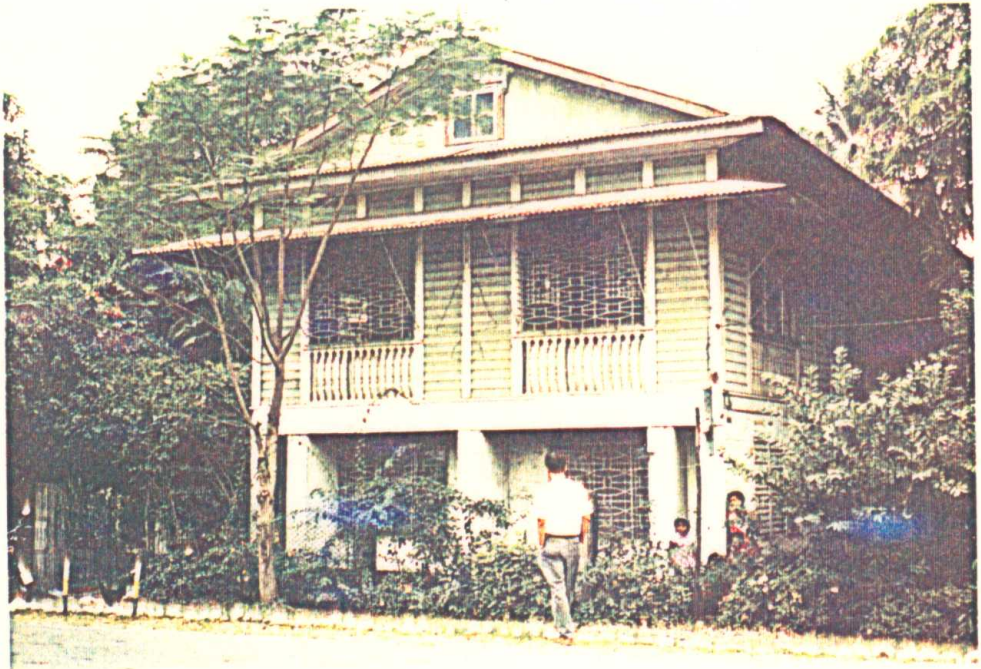
Photo 4.4 Typical larger timber-framed house of early 20th century. Such buildings suffered very very little damage (same damage from the flexing of the structured frame).

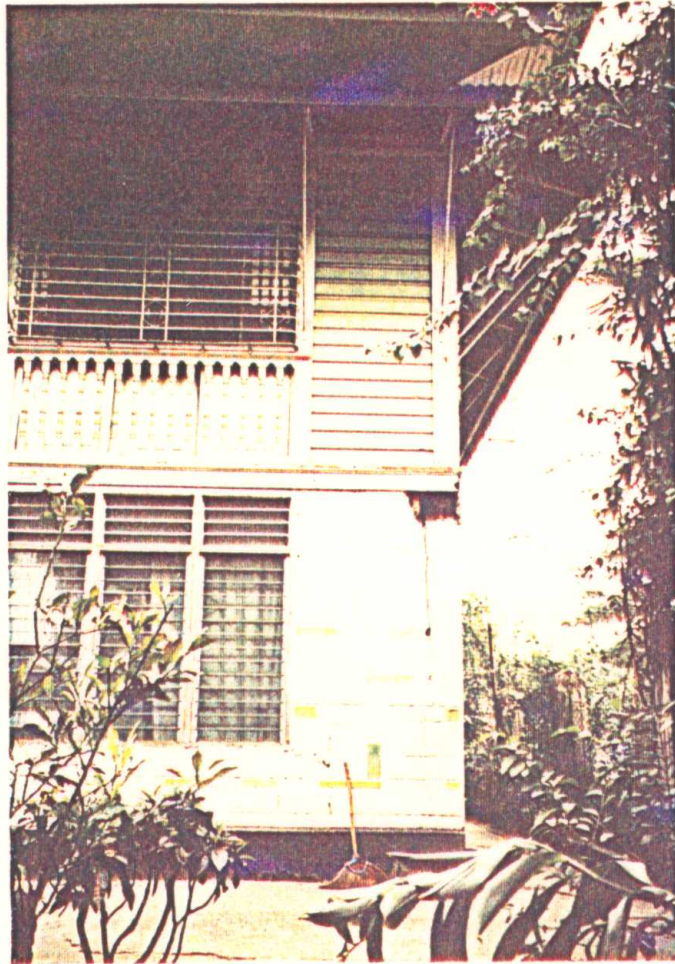
Photo 4.5 Minor cracking to masonry walls enclosing timber framed house - timber frames flexing in the earthquake caused damage to the stiffer masonry. Damage and failure could be expected at larger earthquake intensities.
