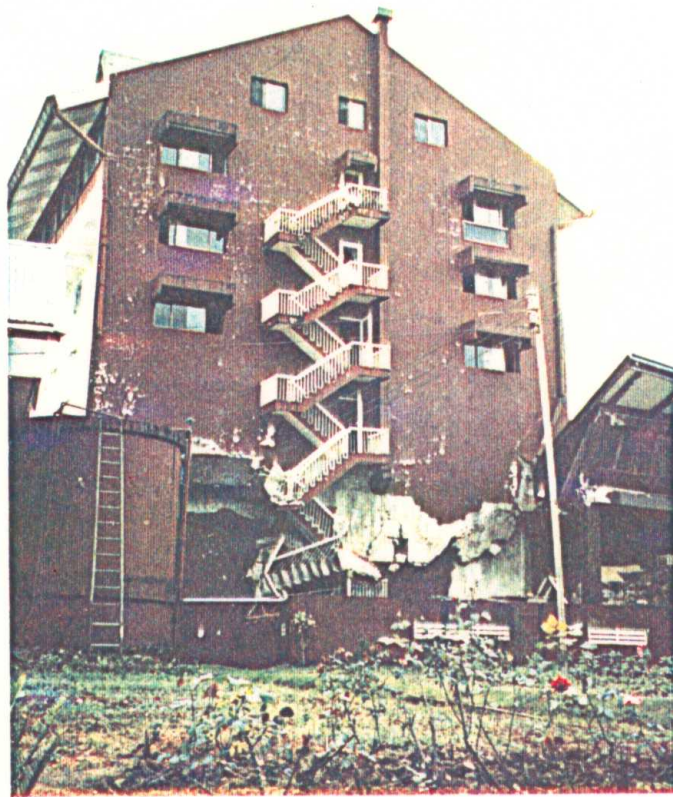
Photo 4.12 Failure of six story Country Club (Baguio City) second floor completely collapsed due to failure of r.c. low ductility frame, deep lintel beams and pronounced torsional effect.

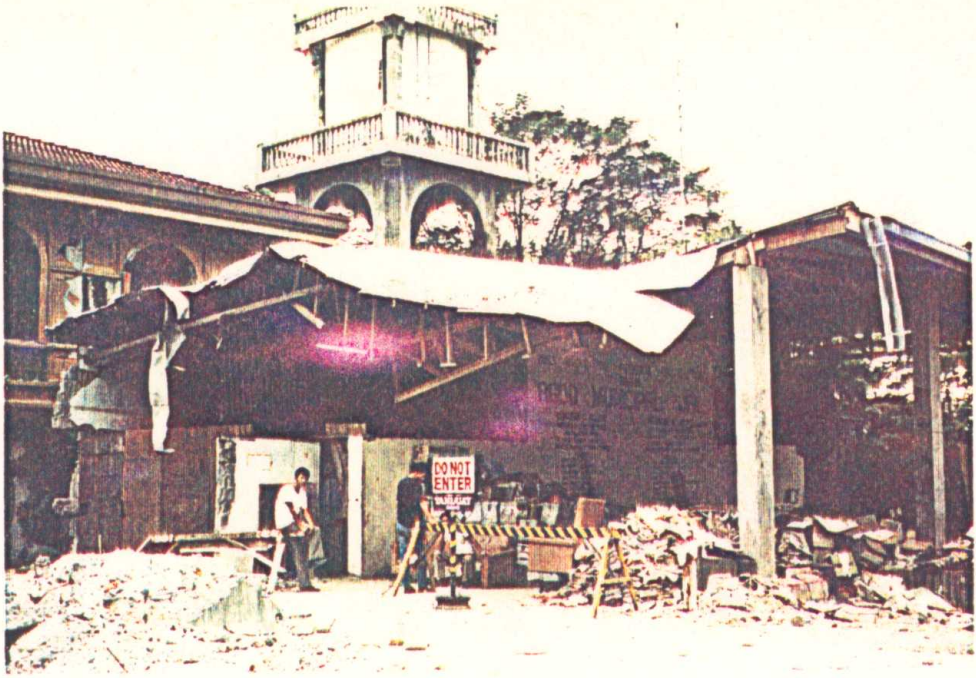
Photo 4.13 Partial failure of the jail building in Ago. No considerations are made to be earthquake-resistant building.

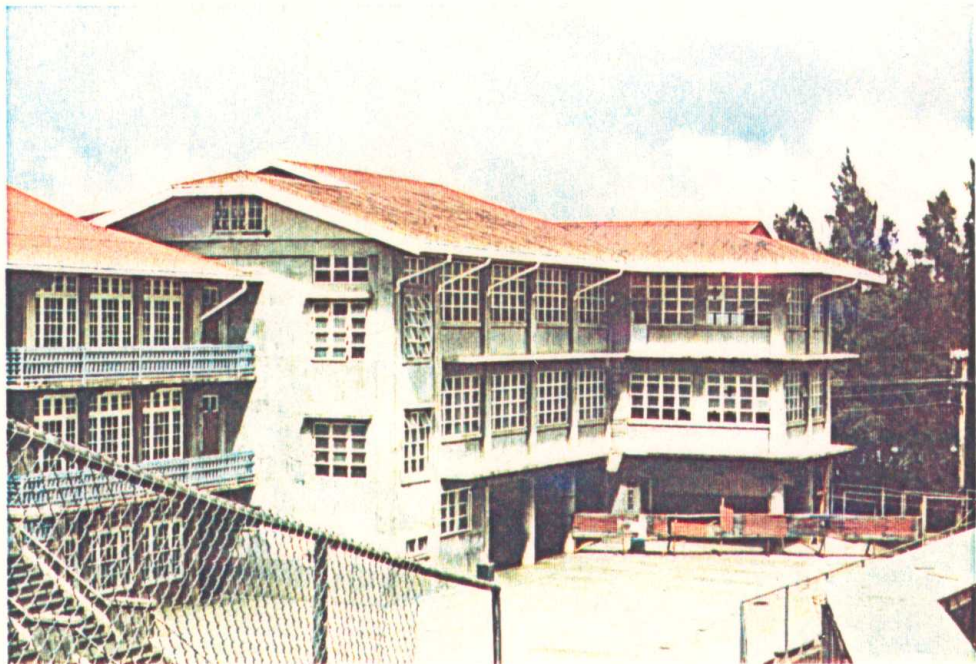
Photo 4.14 Partial structural damage of a 3-story r.c. frame building sited on a low inclined slope (St. Louis Girls High School, Baguio City).

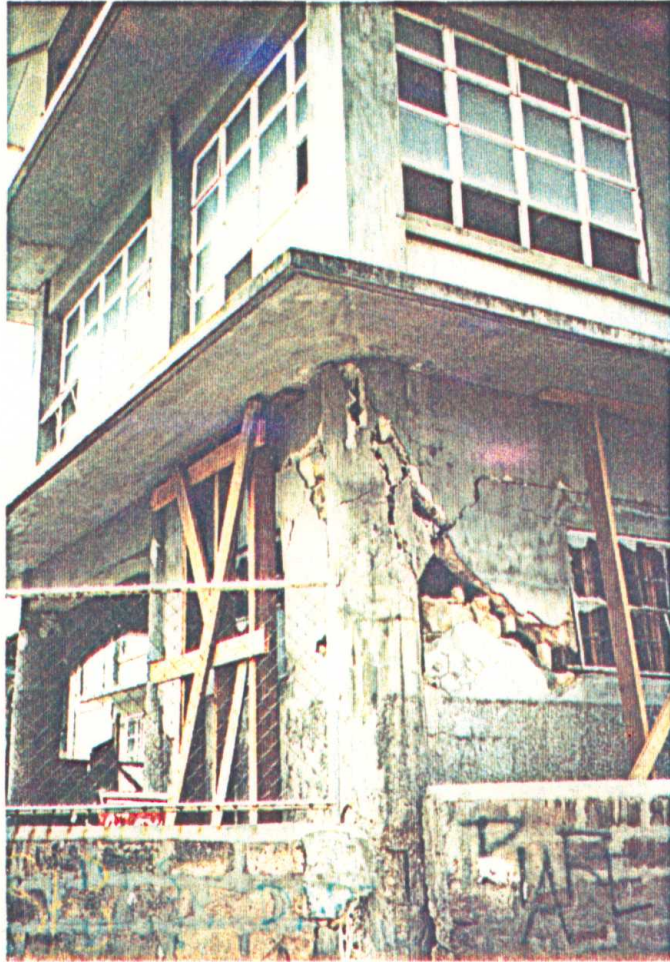
Photo 4.15 Shear mode of failure of r.c. column in the ground floor of the 3-story school building shown in the previous photo.
