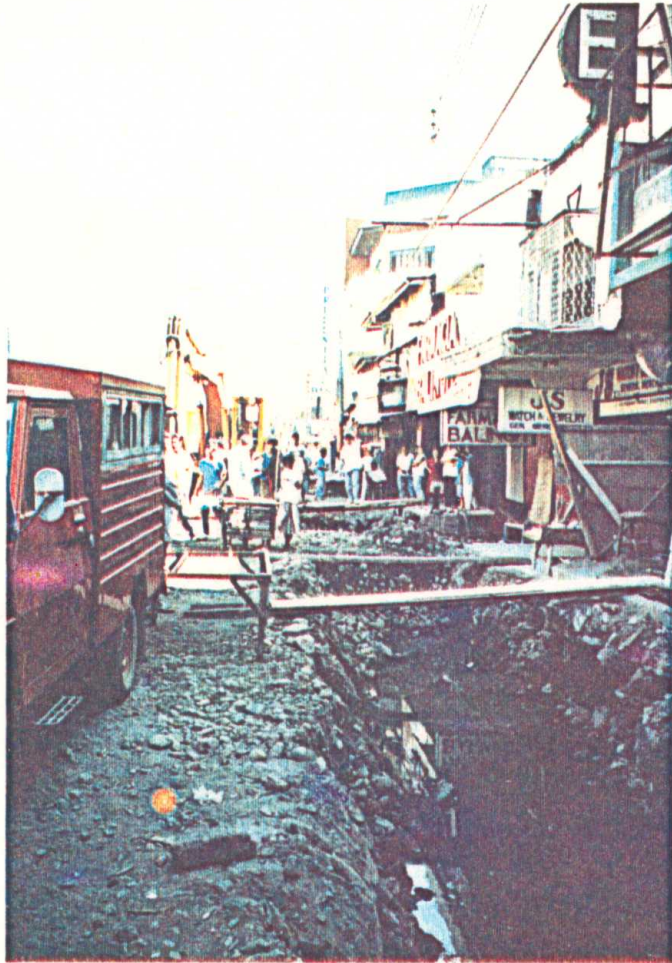
Photo 4.22 Reconstruction of the main sewage line in Hernandez Avenue of Dagupan City. High level of ground water table.

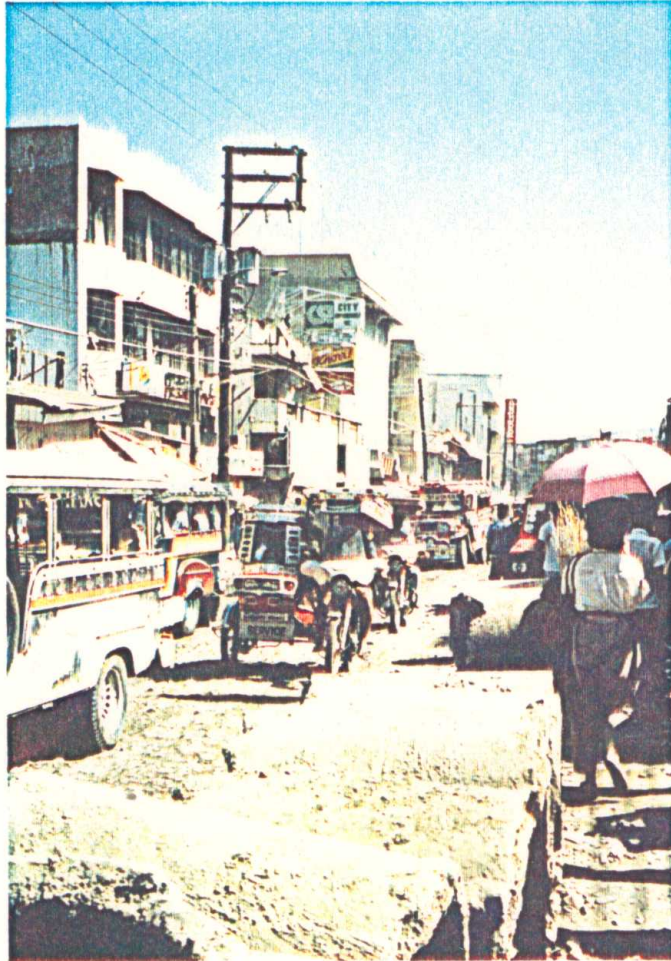
Photo 4.23 View on the Hernandez Avenue and concrete pipes taken out from the sewage line in Dagupan City.

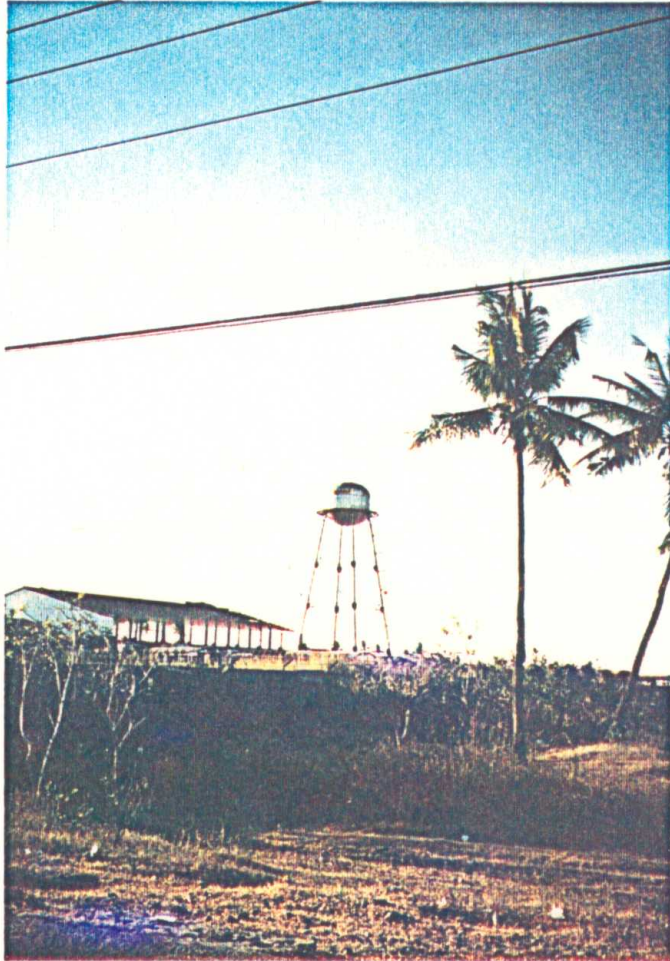
Photo 4.24 Elevated steel water tank near Dagupan City. No damage reported, could be attributed to specific frequency content of earthquake ground motions.
