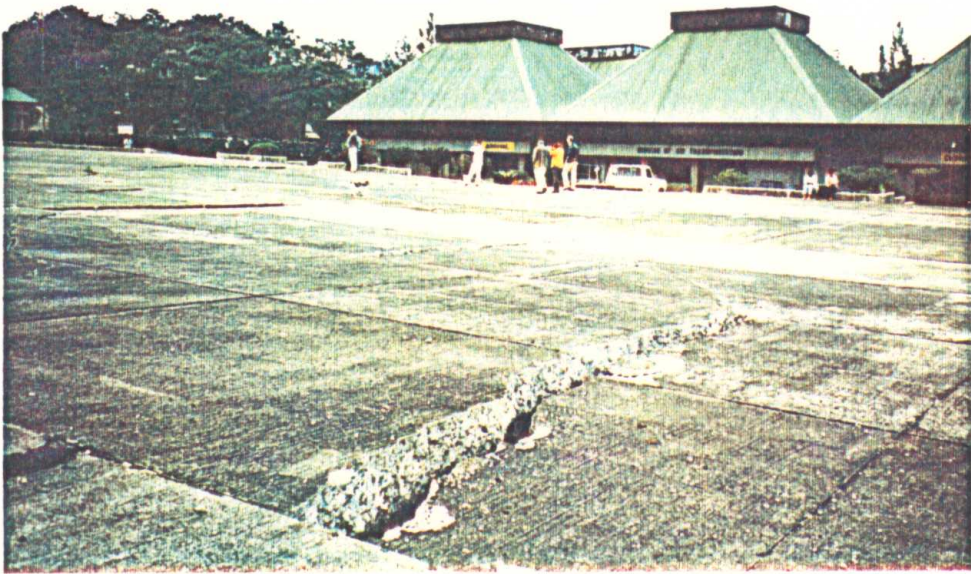
Photo 4.25 Damage due to intensive settlement (20-30 cm.) of the parking and runway at the airport of Baguio City.

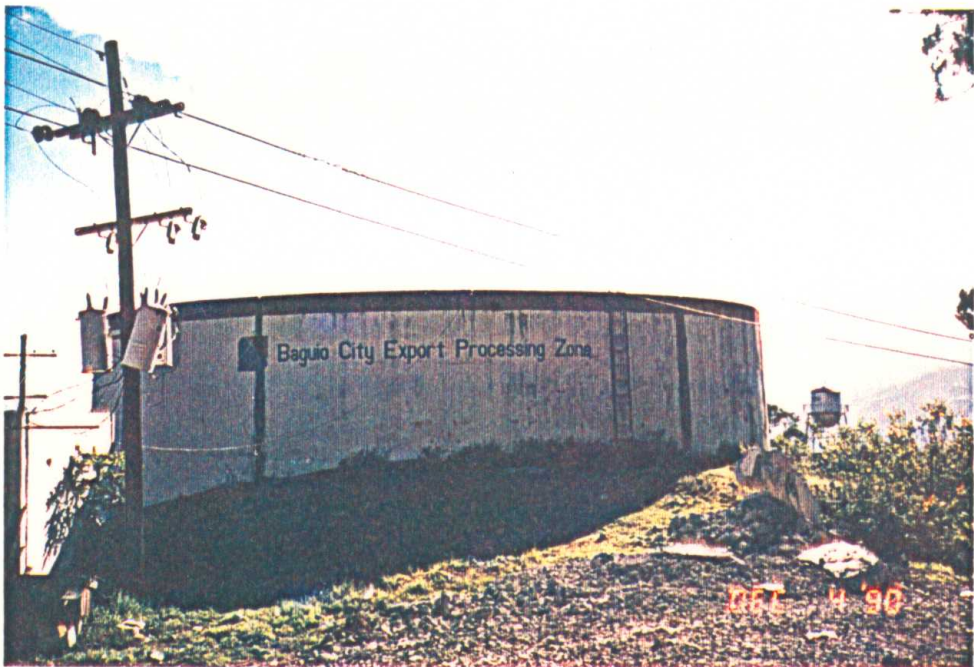
Photo 4.26 Reinforced concrete tank in the Export Processing Zone of Baguio City. No damage is observed, reported failure and heavy damage of the production and storage buildings in the same zone.

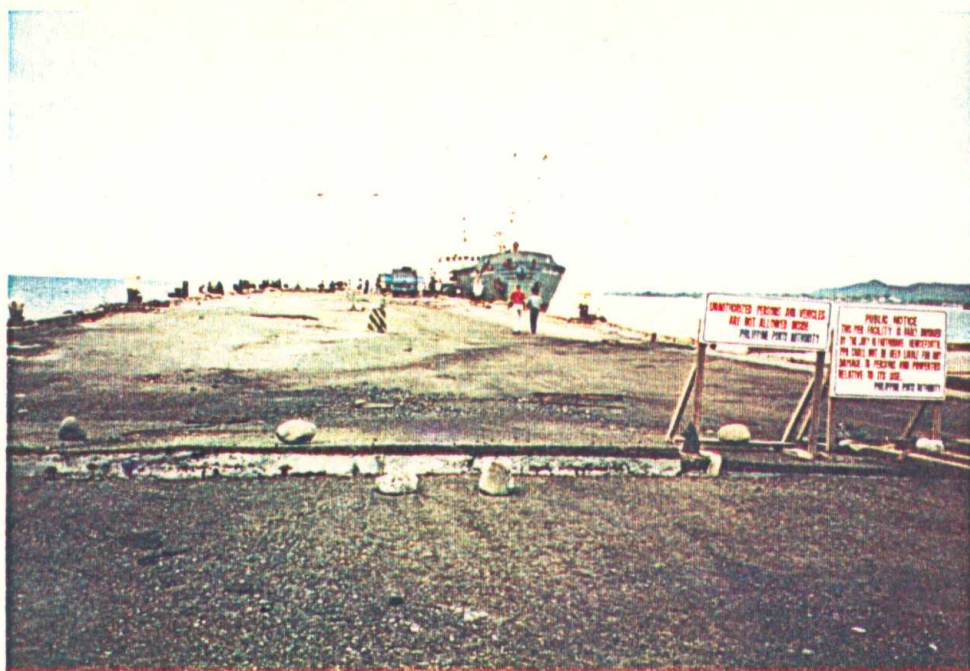
Photo 4.27 Extensive damage in the pier No. 1 in the port of San Fernando. Separation of the pier deck from the shore by 80 cm; intensive settlement and tilting towards the sea.

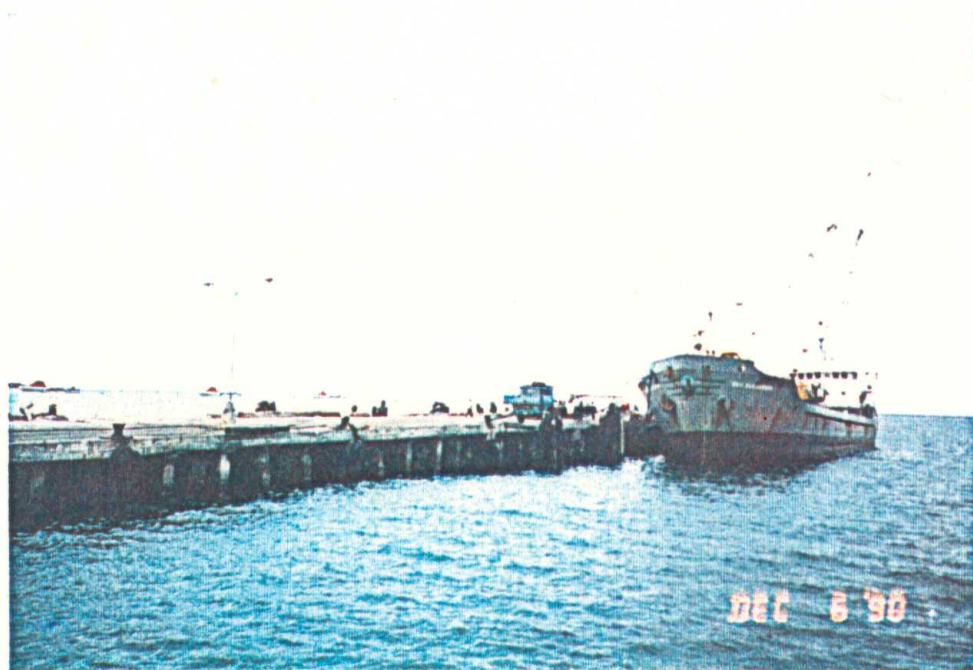
Photo 4.28 Side view on pier No. 1, port of San Fernando. Tilted substructure of the pier by more than 7 degrees toward the sea. Plastic hinges observed at the top of the piles indicating failure in the flexural mode.

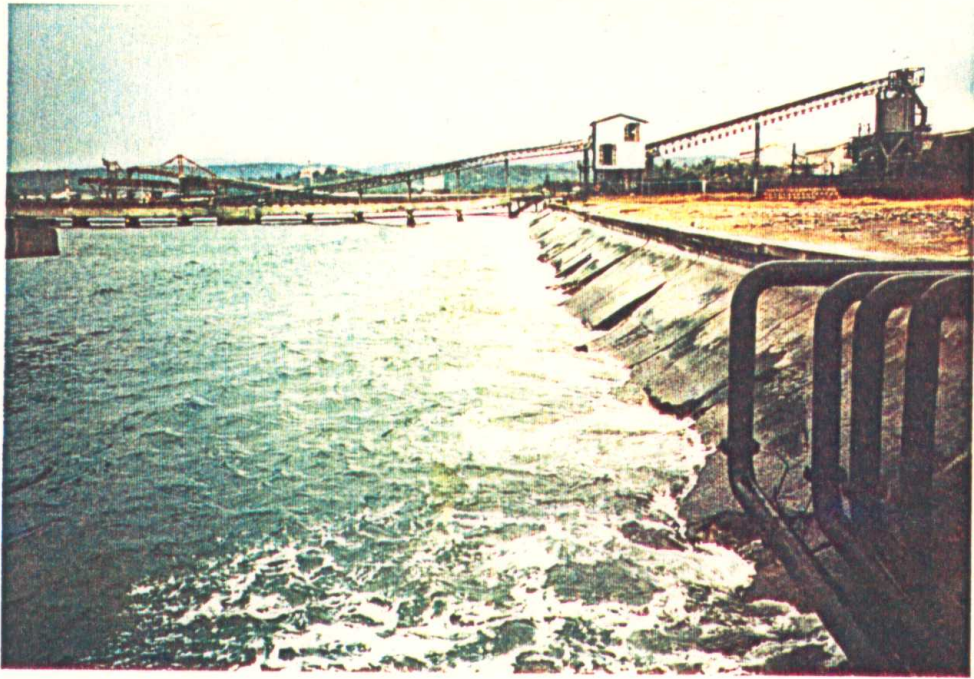
Photo 4.29 Damaged embankment cover at the shore, port of San Fernando.

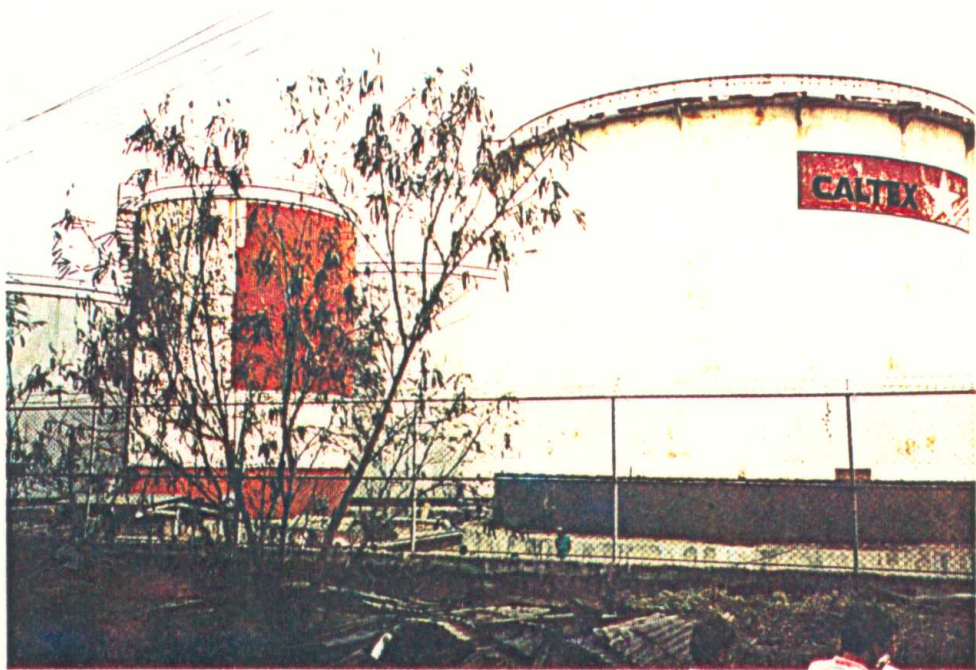
Photo 4.30 Damaged oil tanks in the port of San Fernando. Red portions of the tanks at the lower part (left and right tank), and the upper part - right side tank are indicating damaged parts.
