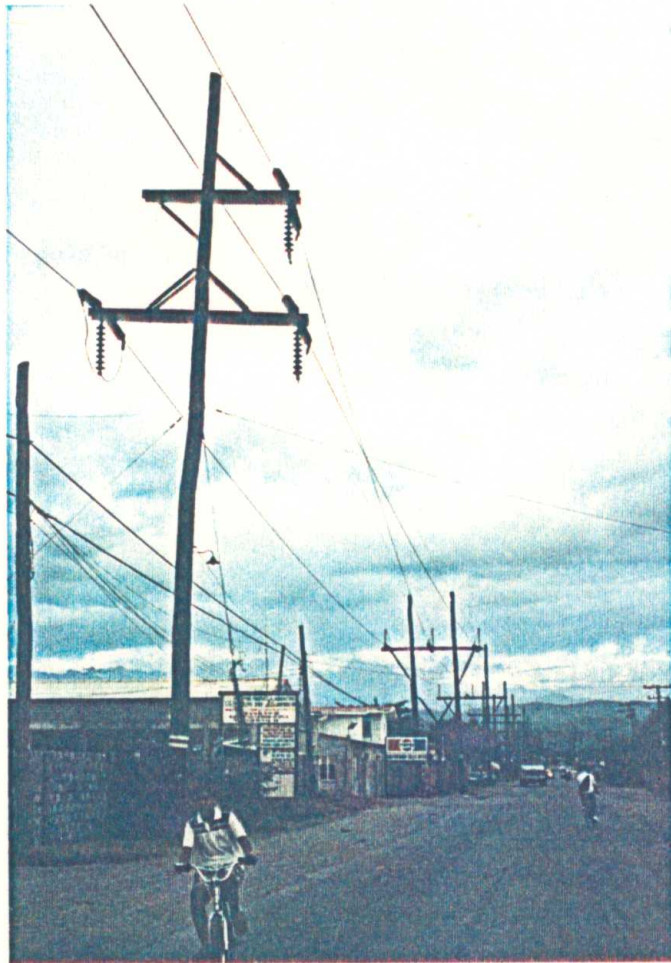
Photo 4.31 Inclination of timber piles of high voltage transmission line in San Fernando. No damage reported on high voltage ceramic breakers at transformer site in the port of San Fernando.

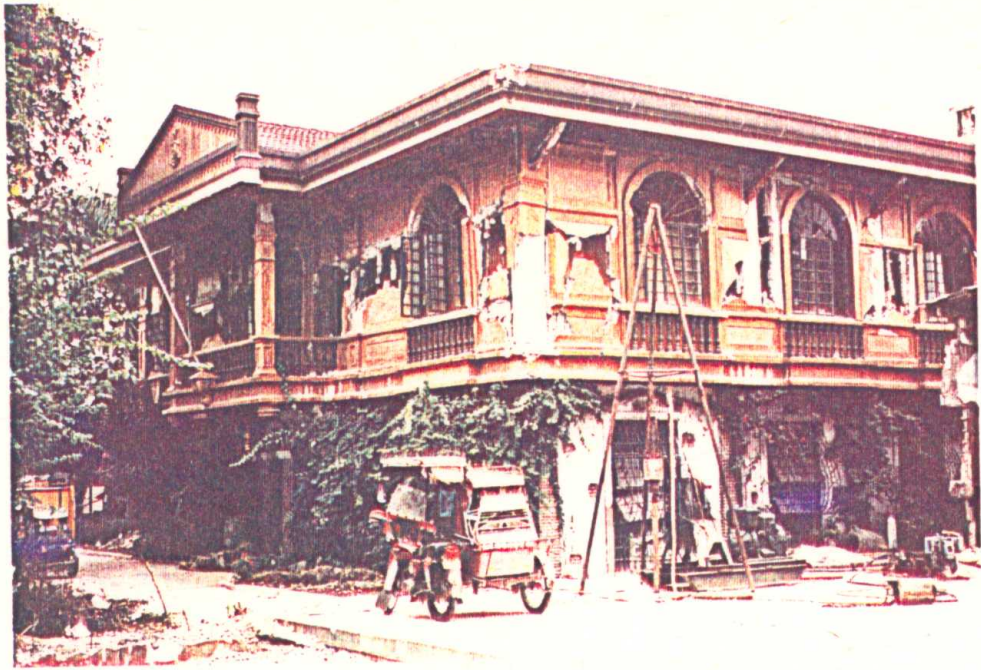
Photo 4.32 Heavily damaged 2 story r.c. frame building of the Museum at Agoo. Dominant nonstructural damage of facade and infill masonry walls.

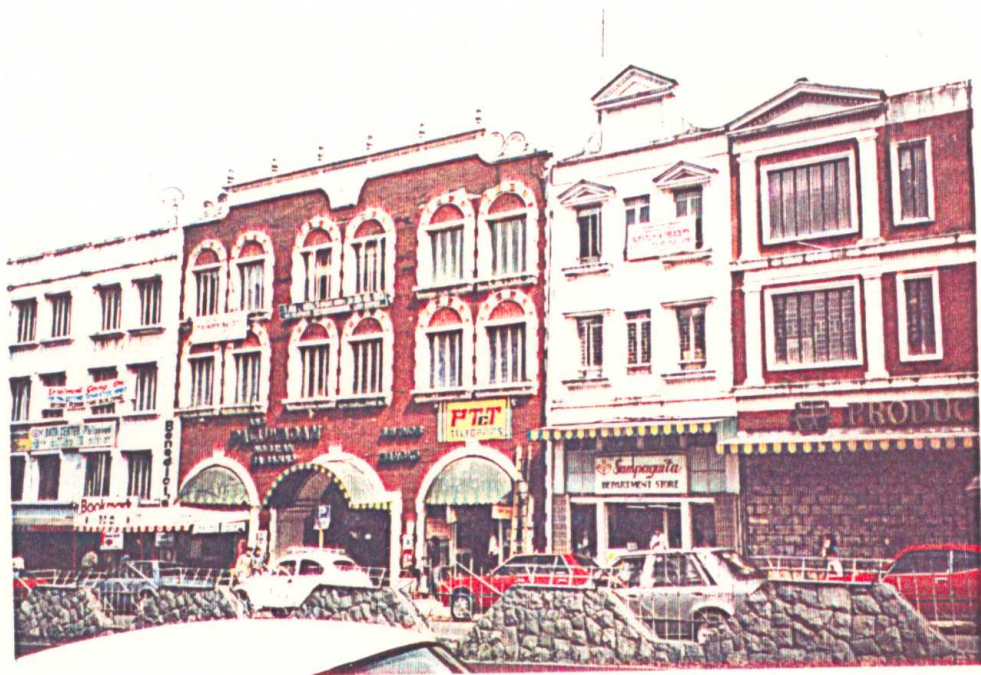
Photo 4.33 Historic townscape of Centre of Baguio City along the Session Road, lightly damaged.

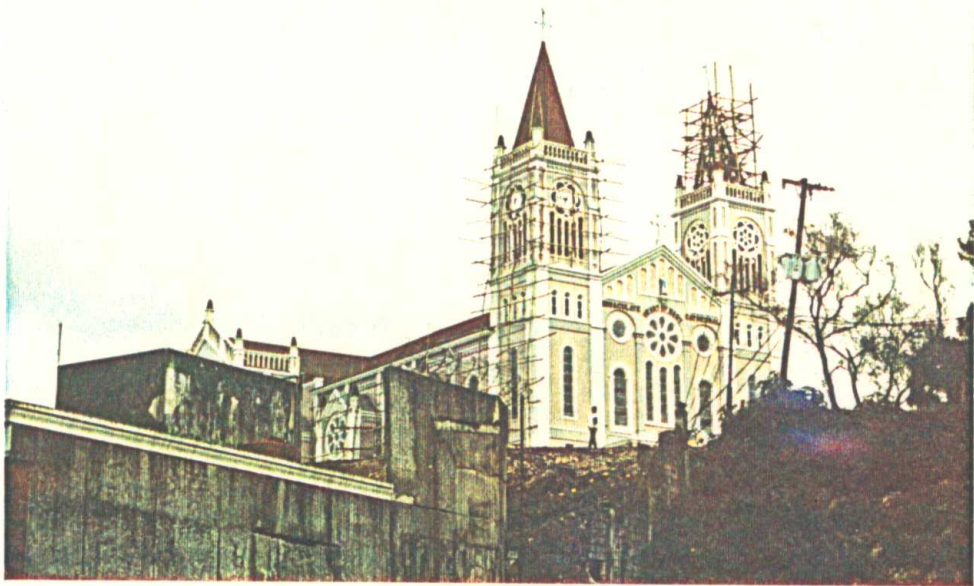
Photo 4.34 Cathedral at baguio City, damaged towers and failure of right side tower indicates dominant frequency content of the earthquake ground motions in Baguio.
