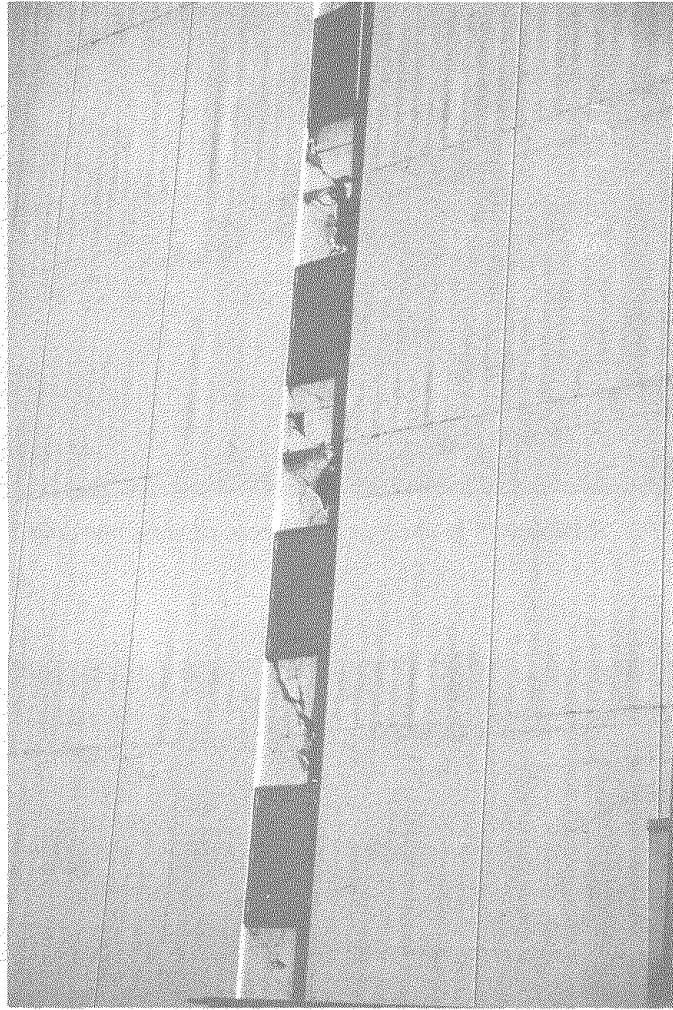
Fig. 31 Detail of shear damage in coupling beams.

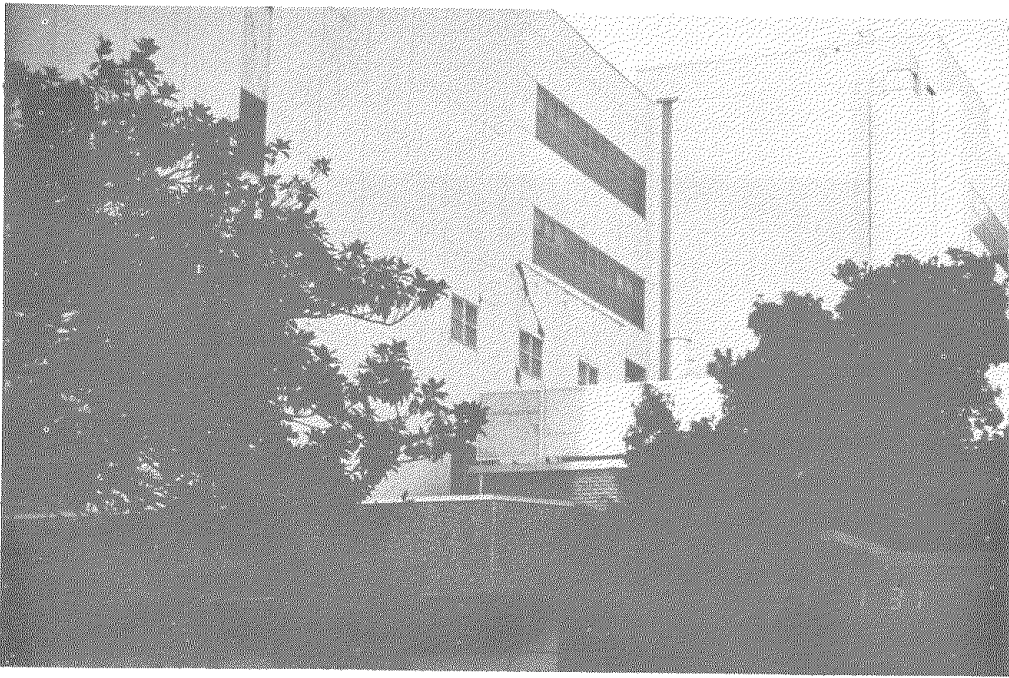
Fig. 32 Shear cracks in concrete walls near window openings.

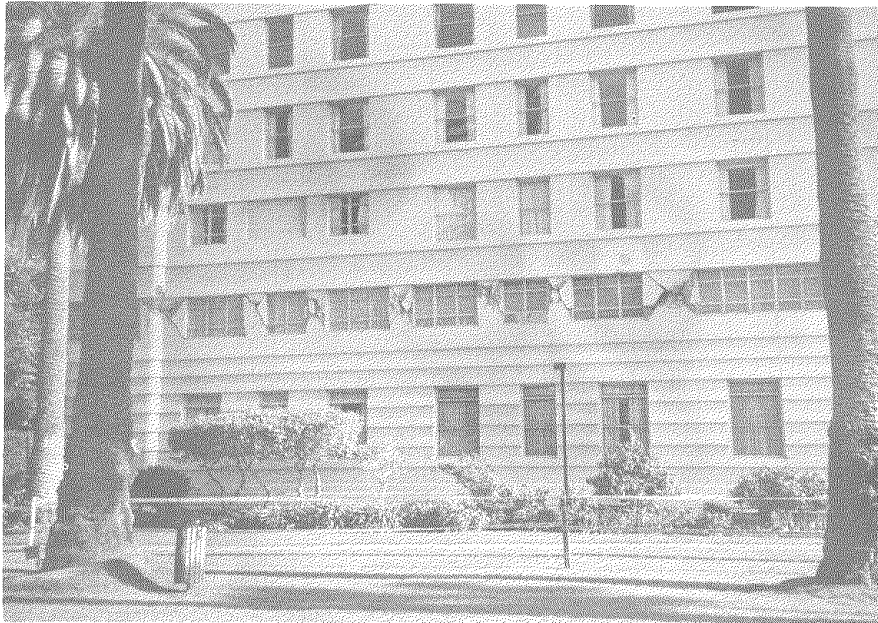
Fig. 33 Shear cracking in columns and wall piers at the second floor in St. John's Hospital.
