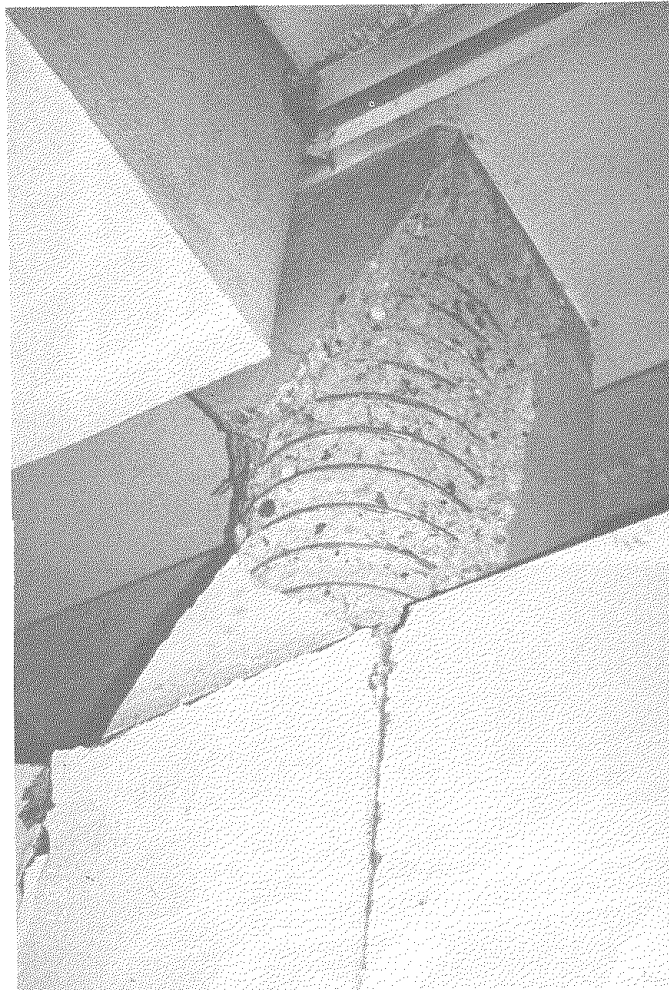
Fig. 48 Short column property confined with spiral reinforcement.

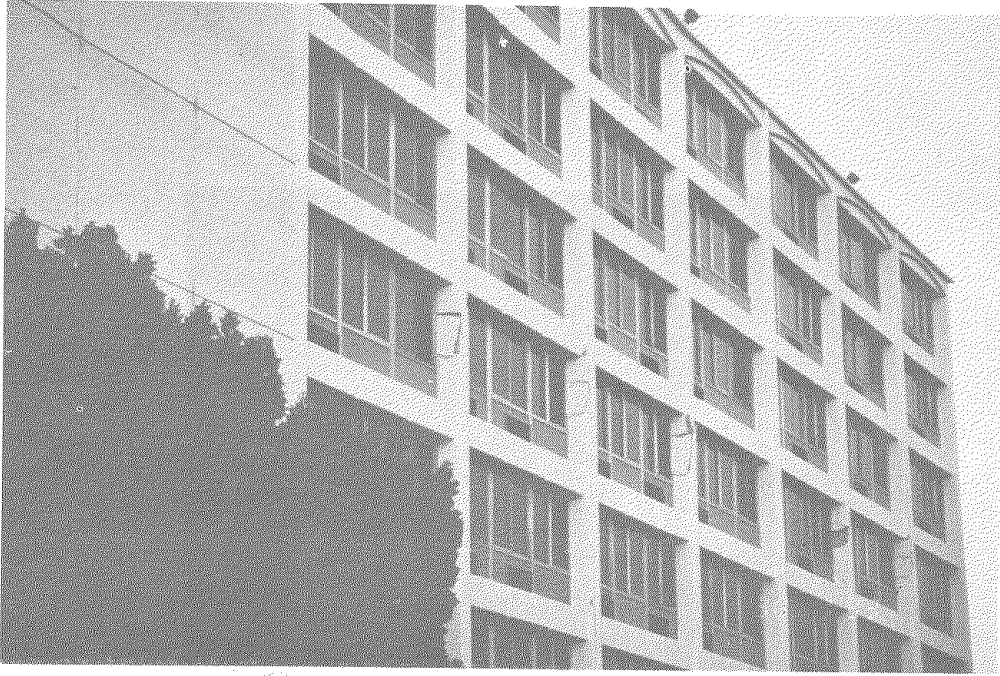
Fig. 49 Diagonal cracking of frame columns.

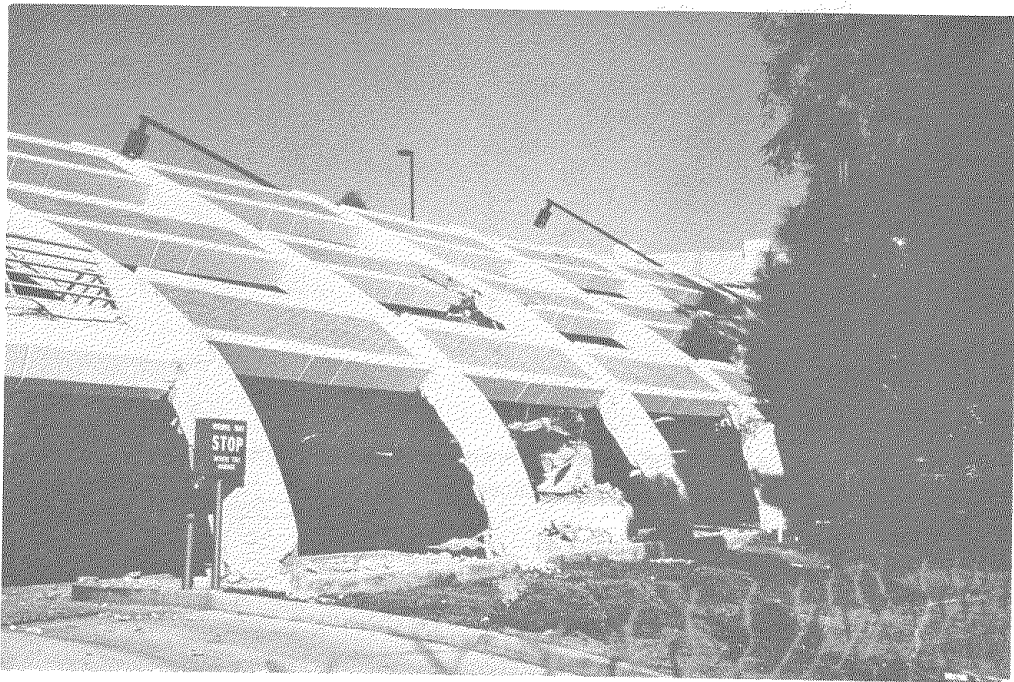
Fig. 50 CSUN parking structure collapse.
