The Bridge as a Machine: Hackensack River Bascule, 1928

Failure of Hackensack Bascule Bridge Found Due to Inadequate Design

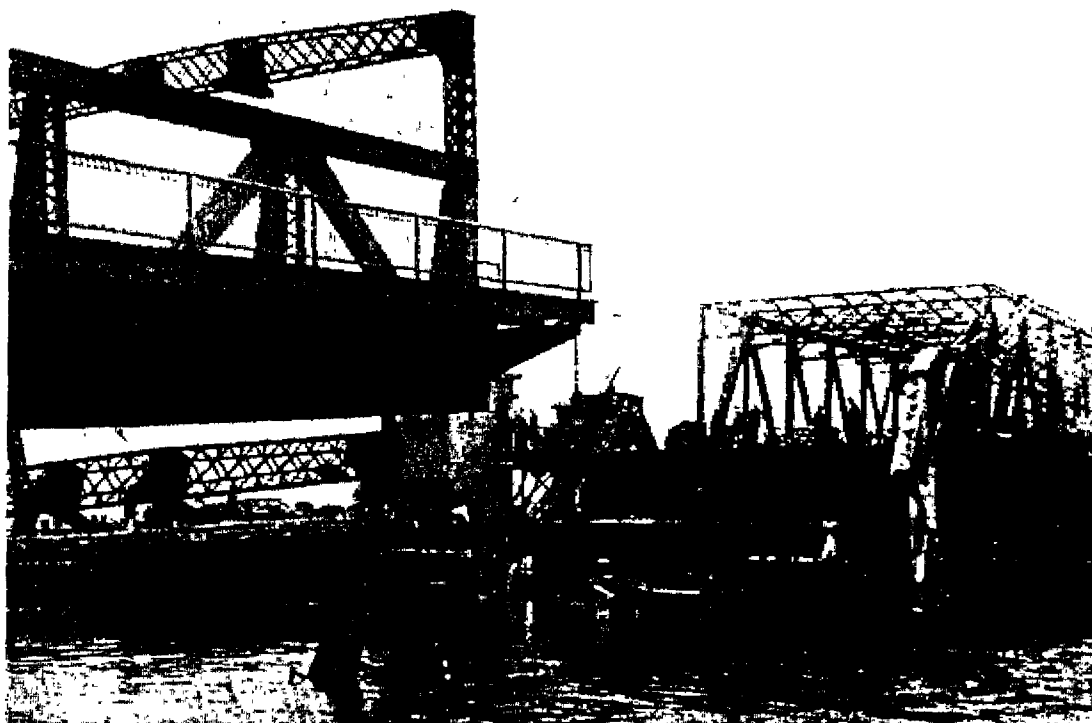
A view of the wreckage [Figure 5-9] shows both the north and south trunnion pedestals in place. The north trunnion bearing, pin and curved rack all fell into the river, only the back end of the rack being visible above the water. The operating pinion is still in place on the pier and undamaged. The complete counterweight structure over this pedestal is also under water, the front channel of the fixed post breaking off at the top of the pedestal and the rear channel leaving a projection of about 18 in. above the top. The break of the front channel showed bright metal and indicated a clean tension break. The break of the rear channel, on the other hand, showed three different conditions of metal. The north flange and about an inch of adjacent web were covered with old rust, indicating a crack of some age. Next to this rust there was a section of web about 8 in. long upon which the break showed bright and coarse texture, while the remainder of the web and the south flange exhibited a somewhat duller color but a more silky texture. The break occurred through the rivet holes holding the lacing and almost straight across. The rivet hole on the north side was lined with old rust, while that on the south side was of the dull silky finish. In front of the trunnion pedestal the live-load support, a low

Figure 5-9 The wrecked east leaf of the Hackensack River bascule on the Lincoln Highway in New Jersey. In the left foreground the undamaged west leaf is shown in the closed position. At left (the north side of the wrecked leaf), the tailpiece and operating rack protrude from the waters of the Hackensack River. (*ENR.*)

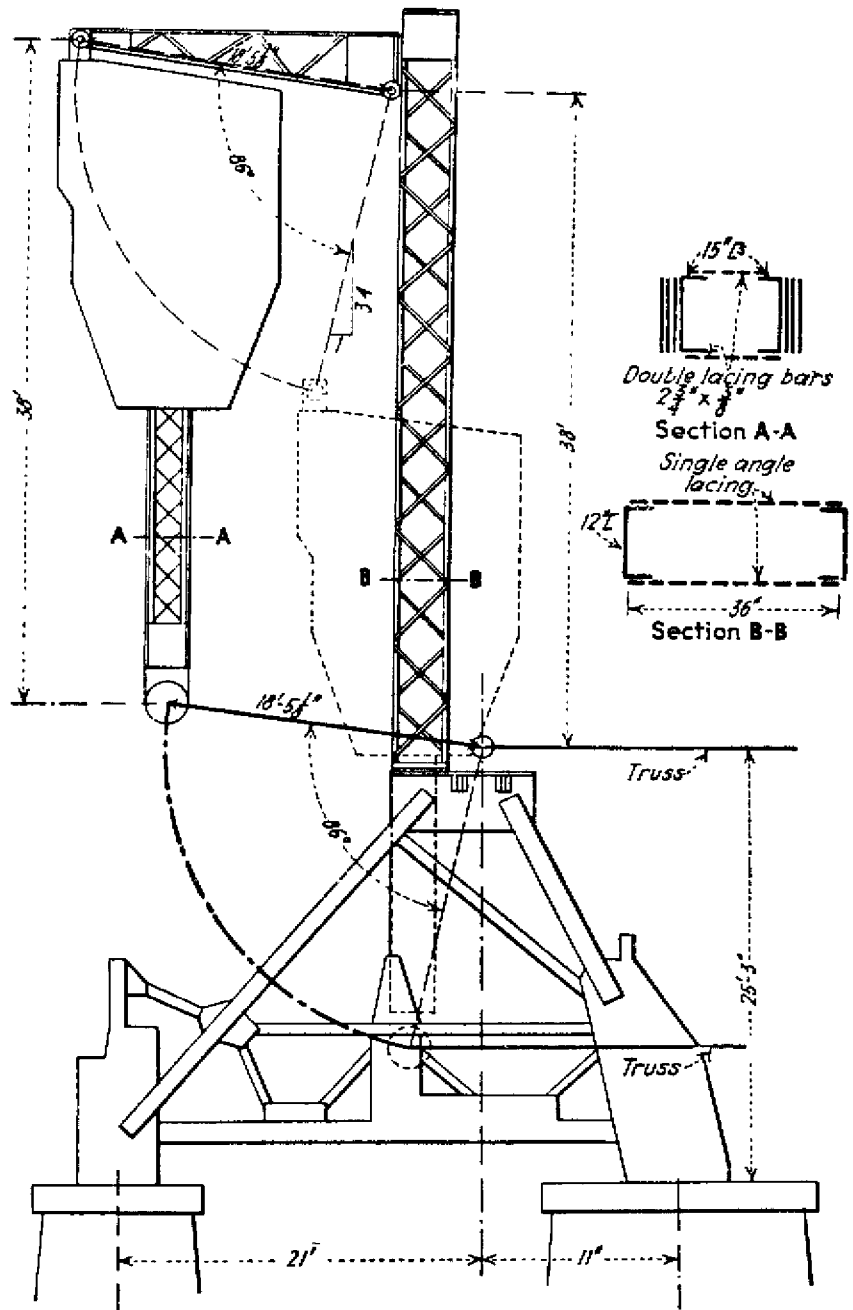
1. The failure of the bridge occurred through the fracture of the north leg of the east counterweight tower, this fracture had been progressive for some time in the past.
2. The cause of the failure was the inadequacy of the design of the counterweight tower to withstand stresses readily calculable from forces known to exist during the normal operation of the bridge. . . .

Figure 5-12 Diagram showing the counterweight system of the Hackensack River bascule. The heavy concrete block at top left was supported on slender latticework. (*ENR.*)

The critical stresses occur at the base of the counterweight tower (as designed), and these stresses are a maximum when the moving leaf is reaching its highest position at the end of the opening operation. At that position the counterweight is moving in a very nearly horizontal direction, which imposes the maximum possible inertia forces on the counterweight tower due to deceleration of the counterweight as brakes are applied. When the leaf is at or near its highest position, assumed in the design and in our computations at an angle of 86 deg. above the horizontal, any horizontal force acting on the counterweight produces a proportional horizontal component in the top link and a simultaneous vertical component amounting to 3.4 times the horizontal component, due to the obliquity of this link. The connection details are such that this vertical component acts with an eccentricity of 27 in. from the center of the counterweight tower leg.
