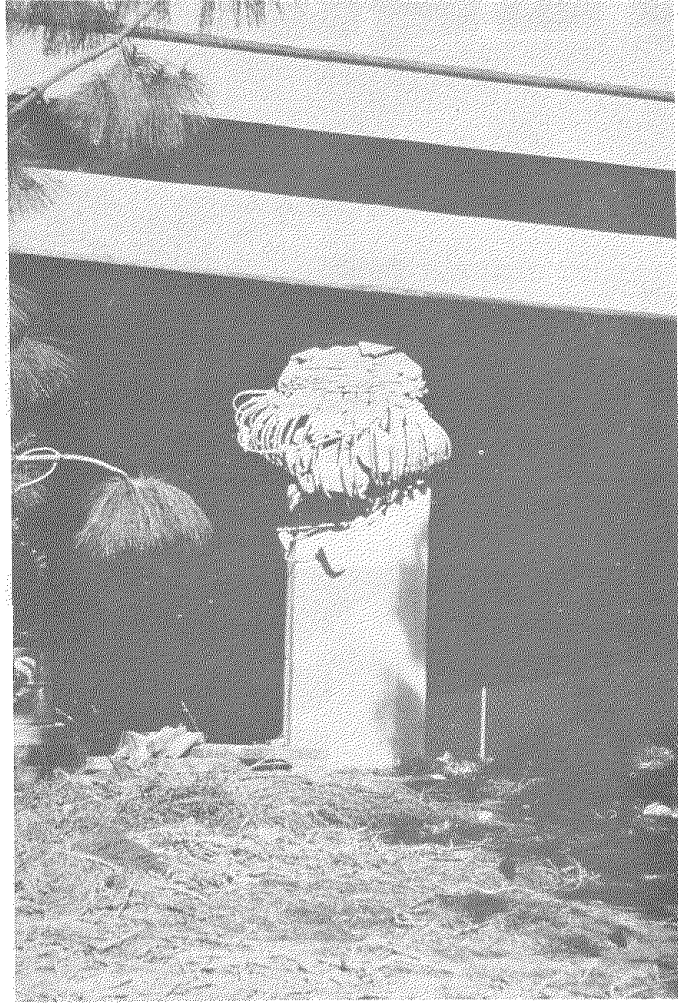
Fig. 28 Column flexural hinging.

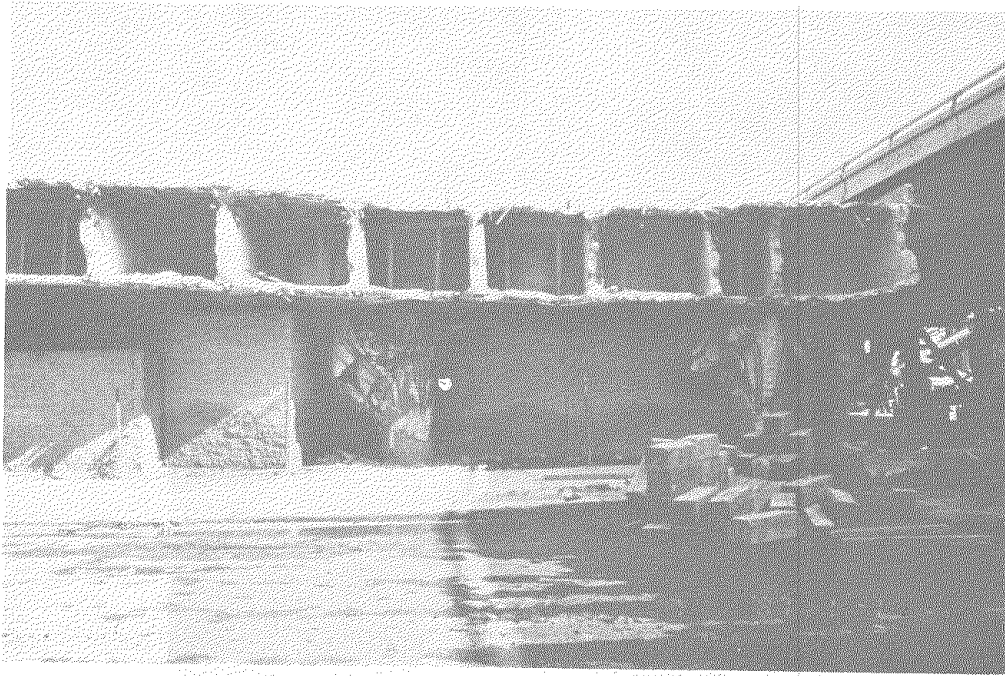
Fig. 29 Impressive buckling of steel bars and concrete crushing along the height.
