The Bridge as a Machine: Hackensack River Bascule, 1928

Failure of Hackensack Bascule Bridge Found Due to Inadequate Design

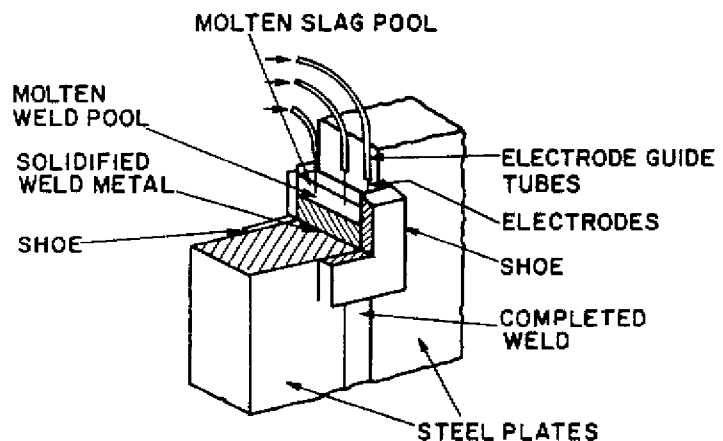
Figure 5-8 In electroslag welding, electrode wires become molten along with the ends of the members being joined. They solidify to weld the sections together. (ENR.)
