Annex 1
Examples of Effects of Earthquakes
on Pipeline Systems*
(1969 - 1997)

Annex 2

Application of Vulnerability Analysis: Case study of Limón, Costa Rica

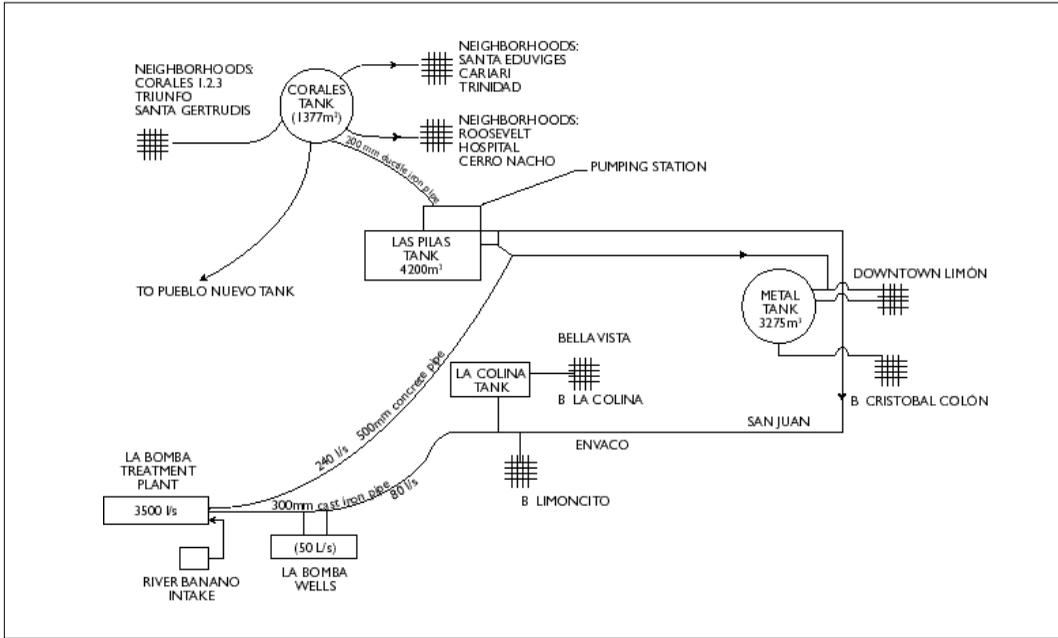
Figure A1.
Water Conveyance and Distribution for the Banano River Subsystem

- The conveyance pipeline was made up mainly of 350 mm diameter pipe, installed in 1981, with Tyton type jointss. The pipe is located primarily in alluvial soil and clay.
- Treatment plant: The settling tank consisted of a reinforced concrete tank; in addition there were units for rapid mixing, flocculation, sedimentation, and filtration.

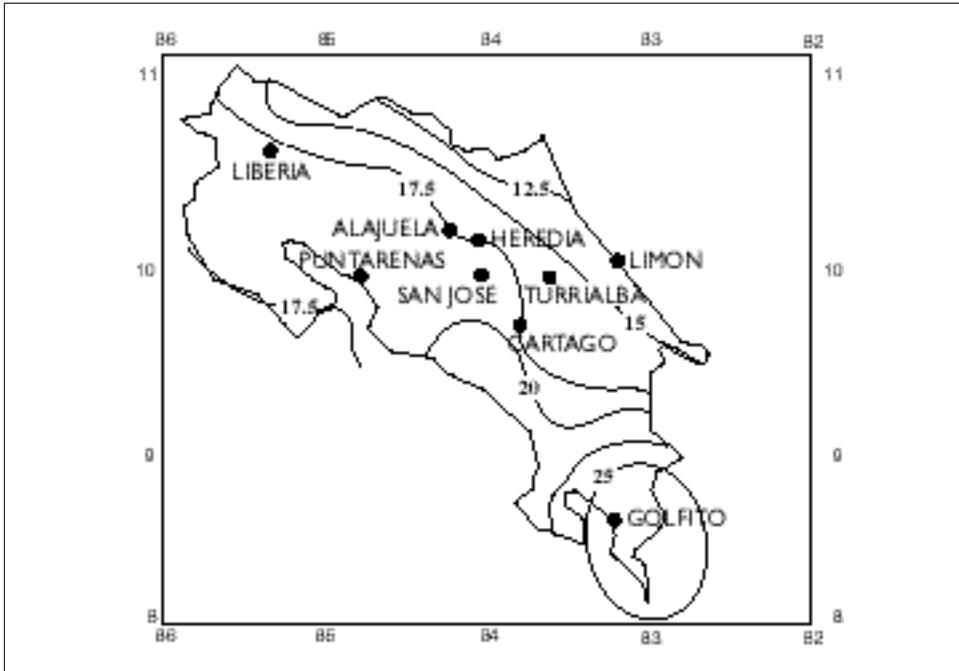
Figure A2.
Isoaccelerations for a 100-year return period (Costa Rica)

Seismic risk in Costa Rica is illustrated in Figure A.2. While the city of Limón is located in a zone of relatively low seismic risk, it sustained major damage in the 1991 earthquake.
