PAN AMERICAN HEALTH ORGANISATION
 VULNERABILITY ASSESSMENT OF THE
 DRINKING WATER SUPPLY INFRASTRUCTURE
 OF MONTSERRAT
 David A. Lashley
 David Lashley & Partners Inc.
 July 1997.
*Figure 6- Volcanic Risk Map
 Updated February 1997*

1.2.2 The Second Visit

1.3 Brief History of Recent Volcanic Activity

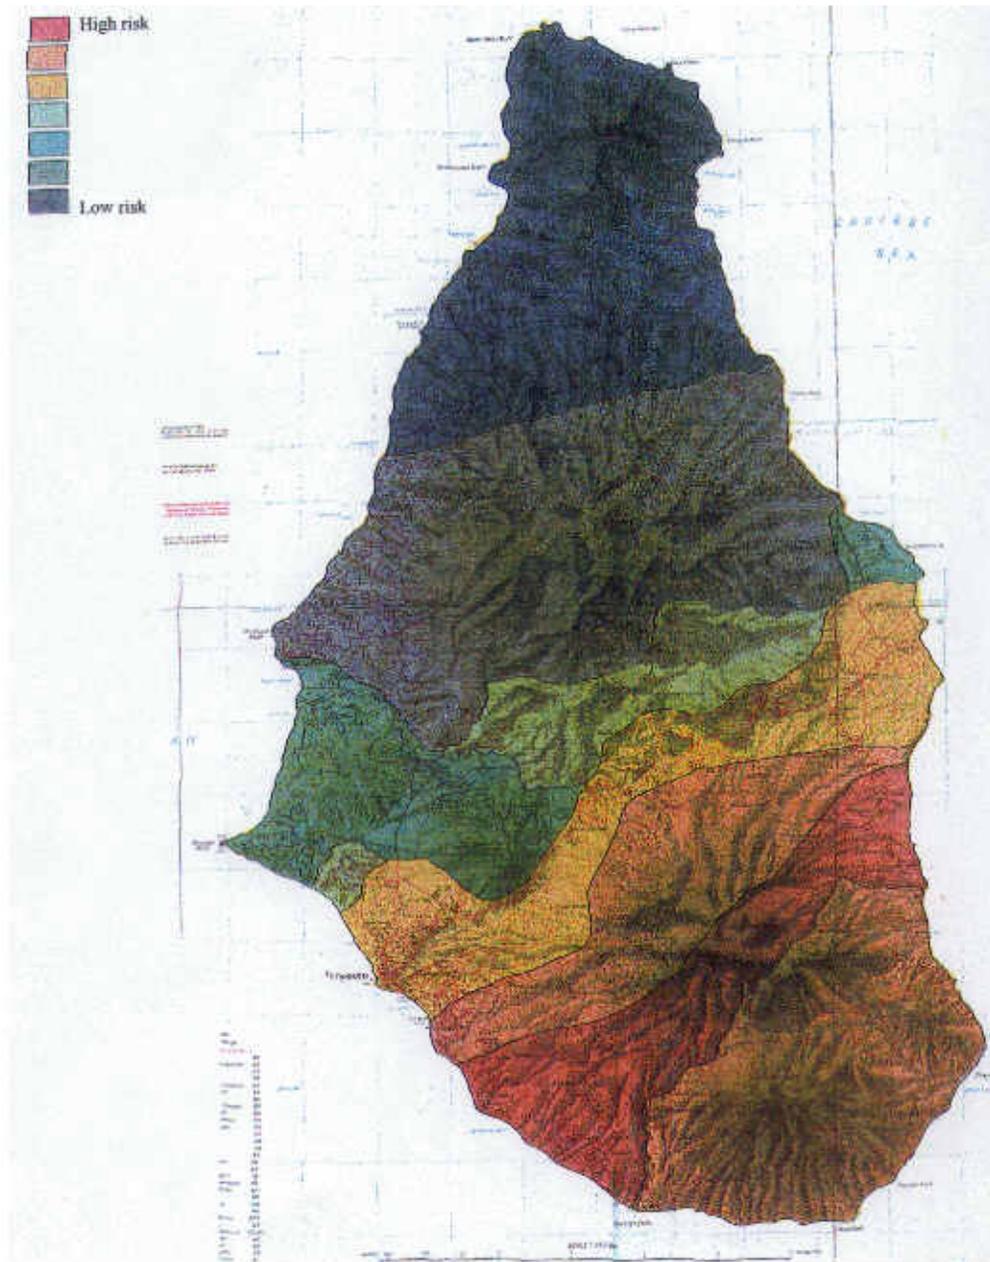
1. Colour chart indicates increasing risk zones based on an evaluation of the hazard.
2. The status of each of the zones is dependent on the alert level.
3. Potential hazards include: pyroclastic flows, surges, falling rocks and ash fall hazards.
